STM32F100x4, STM32F100x6, STM32F100x8 and STM32F100xB low and medium-density value line device limitations

Silicon identification

This errata sheet applies to the revision Z of the STMicroelectronics low and medium-density STM32F100xx value line products.

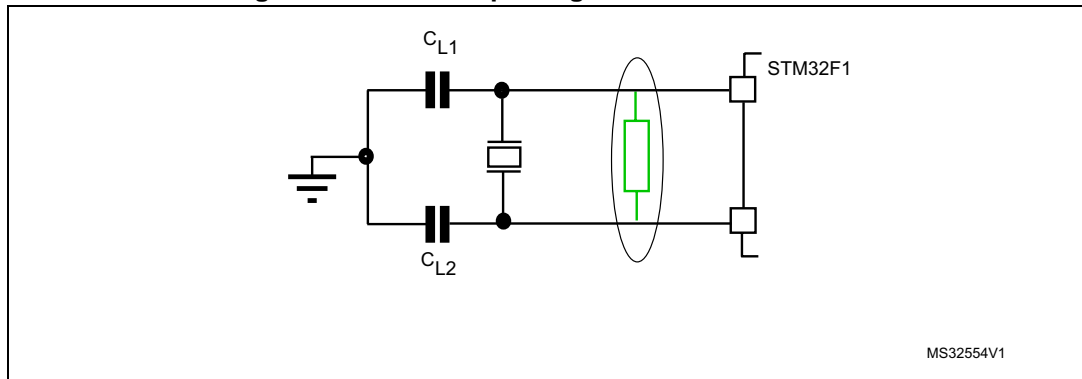
Figure 1. LSE start-up using an additional resistor

The LSE (Low Speed External) oscillator system has been designed to minimize the overall power consumption of the STM32F1 microcontroller. It is extremely important to take specific care in the design of the PCB to ensure this low power oscillator starts in harsh conditions. In some PCB designs without coating, an induced low leakage may prevent the LSE to start-up, regardless of the 32.768 KHz crystal used. This phenomenon is amplified in humid environments that create frost on the OSC32_IN/OSC32_OUT tracks. This unwanted behavior may happen only at the first back-up domain power-on of the device.

It is recommended to mount an additional parallel feedback resistor (from 16 MΩ to 22 MΩ) on board to help the oscillation start-up in all cases (see [Figure 1](#)). For more details on compatible crystals and hardware techniques on PCB, refer to AN2867 application note.
