STM32F101x4/6, STM32F102x4/6 and STM32F103x4/6 low-density device limitations

Silicon identification

This errata sheet applies to the revision A of the STMicroelectronics low-density STM32F101xx access line, STM32F102xx USB access line and STM32F103xx performance line products. These families feature an ARM® 32-bit Cortex®-M3 core, for which an errata notice is also available (see [Section 1](#) for details).

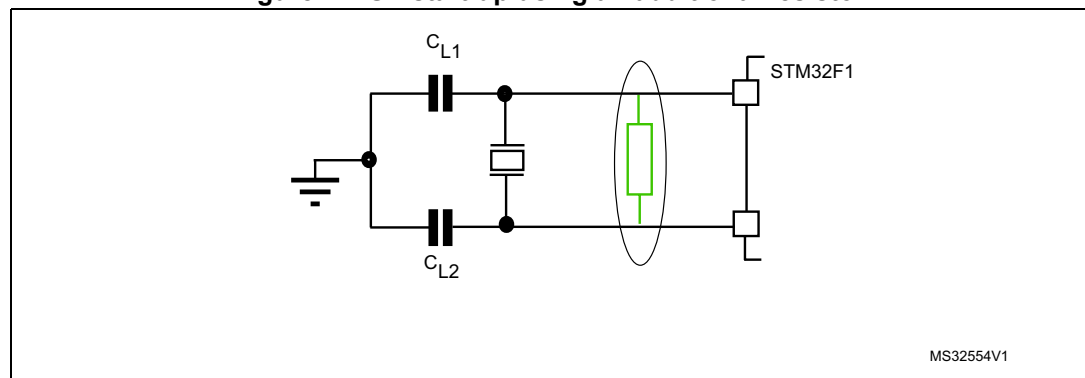
Figure 1. LSE start-up using an additional resistor

The LSE (Low Speed External) oscillator system has been designed to minimize the overall power consumption of the STM32F1 microcontroller. It is extremely important to take specific care in the design of the PCB to ensure this low power oscillator starts in harsh conditions. In some PCB designs without coating, an induced low leakage may prevent the LSE to start-up, regardless of the 32.768 KHz crystal used. This phenomenon is amplified in humid environments that create frost on the OSC32_IN/OSC32_OUT tracks. This unwanted behavior may happen only at the first back-up domain power-on of the device.

It is recommended to mount an additional parallel feedback resistor (from 16 M Ω to 22 M Ω) on board to help the oscillation start-up in all cases (see [Figure 1](#)). For more details on compatible crystals and hardware techniques on PCB, refer to AN2867 application note.
