## Silicon identification

This errata sheet applies to revisions X, Y/6, V, W/7 and 1 of the STMicroelectronics STM8S007xx and STM8S20xxx products.

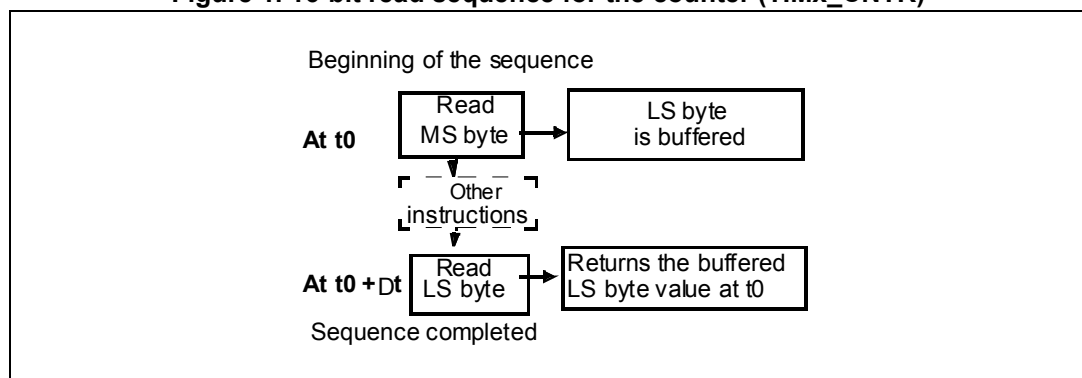
**Figure 1. 16-bit read sequence for the counter (TIMx\_CNTR)**

When any multi-cycle instruction precedes the read of the LSB, the content of the buffer is lost and the second read returns the immediate content of the counter directly.

Do not use multi-cycle instructions before reading the LSB.
