This application note seeks to correct a problem that may occur when using the **In Situ Programming (ISP)** feature on **ST7MDT1-DVP2** and **ST7MDT2-DVP2** development kits.

## Workaround to ISP Mode Limitation on the ST7MDT1-DVP2 and ST7MDT2-DVP2

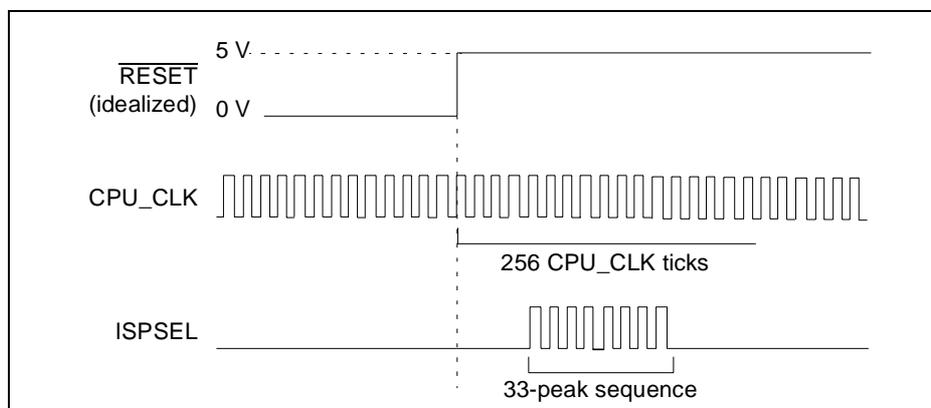
Normally, when there is no capacitance at the  $\overline{\text{RESET}}$  pin, ISP mode is initiated by the following sequence, illustrated in [Figure 1](#):

**Figure 1: "Ideal" signal transmission at ISP mode initiation ( $\overline{\text{RESET}}$  pin has no capacitance)**

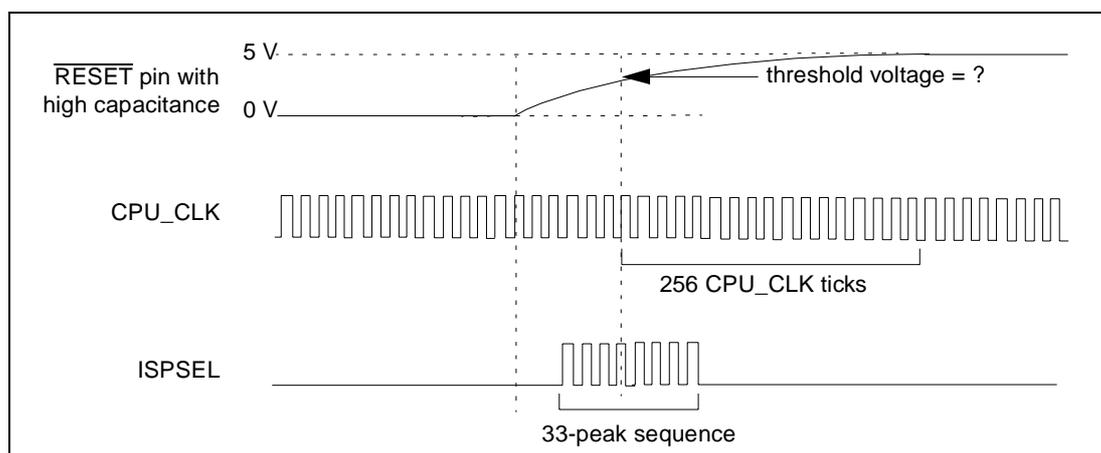
The problem arises when (for various worthy reasons) you have designed your application board with protections that result in a high capacitance at the target MCU's  $\overline{\text{RESET}}$  pin. The result is that following a chip reset, the return of the pin to 5 V can be very gradual, rather than instantaneous.

As the voltage gradually rises at the  $\overline{\text{RESET}}$  pin, at some unknown threshold voltage (probably in the vicinity of 3.5 V, but this is dependent on several factors), the target MCU begins to count out 256 CPU\_CLK timer ticks, during which time the MCU is "listening" for the ISPSEL signal.

However, because the ISPSEL signal sequence is sent from the ISP driver independently of the  $\overline{\text{RESET}}$  pin value, in a high capacitance scenario it becomes very likely that the 33-peak ISPSEL signal sequence will begin transmission before the MCU is ready to receive it (i.e. before the voltage on the  $\overline{\text{RESET}}$  pin has reached its threshold value). [Figure 2](#) illustrates this sequence of events.

The result is that the target MCU doesn't receive the ISPSEL signal sequence in its entirety and therefore cannot be put into ISP mode to accept programming.

**Figure 2: Signal transmission when  $\overline{\text{RESET}}$  pin has high capacitance**

The first way to ensure that ISP mode functions correctly is to design your application board so that the RESET pin has low capacitance.

However, we recognize that this isn't always possible, and so have provided a workaround involving the following three steps:

- 1 Updating your version of WINEE (Windows Epromer) to version 4.0.
- 2 Modification to the DVP hardware—linking several pins of the ISP driver chip together by soldering two wires.
- 3 Reprogramming the ISP driver firmware.

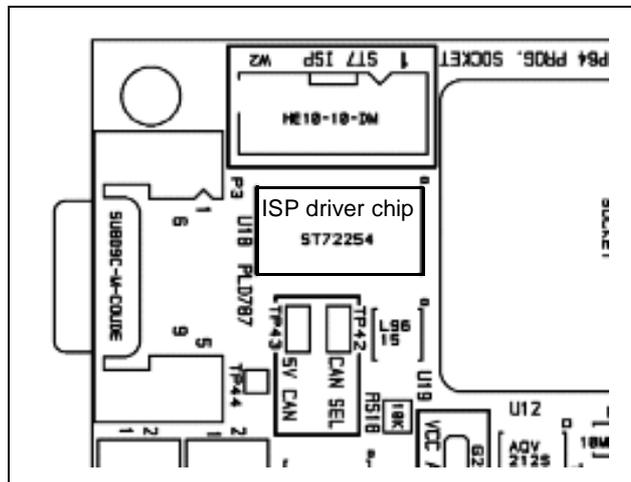
Figure 3: Location of ISP driver chip on the ST7MDT2-DVP2

- 1 Locate the ISP driver chip (ST72254), in the corner of the DVP board, close to the ISP connector. *Figure 3* shows the location of the driver chip (labelled U18) for the ST7MDT2-DVP2. The driver chip is in a similar location (labelled U17) on the ST7MDT1-DVP2.
