## Applicability

This document applies to the part numbers of STM32F031x4/x6 devices listed in [Table 1](#) and their variants shown in [Table 2](#).

# 1 Summary of device errata

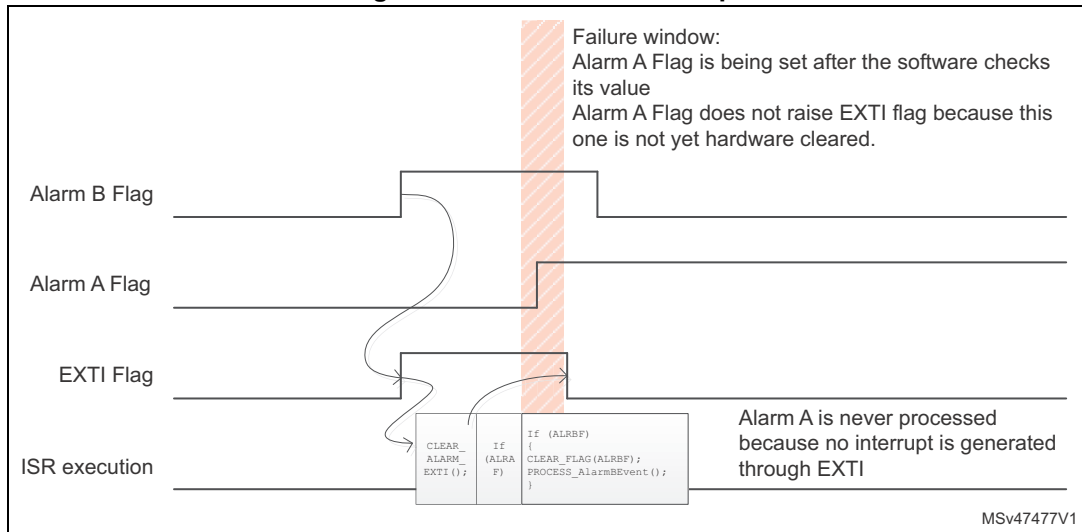
Figure 1. Masked RTC interrupt

The following code example and figure illustrate the failure mechanism: The Alarm A event is lost (fails to generate interrupt) as it occurs in the failure window, that is, after checking the Alarm A event flag but before the effective clear of the EXTI interrupt flag by hardware. The effective clear of the EXTI interrupt flag is delayed with respect to the software instruction to clear it.

In the interrupt service routine, apply three consecutive event flag checks - source one, source two, and source one again, as in the following code example:

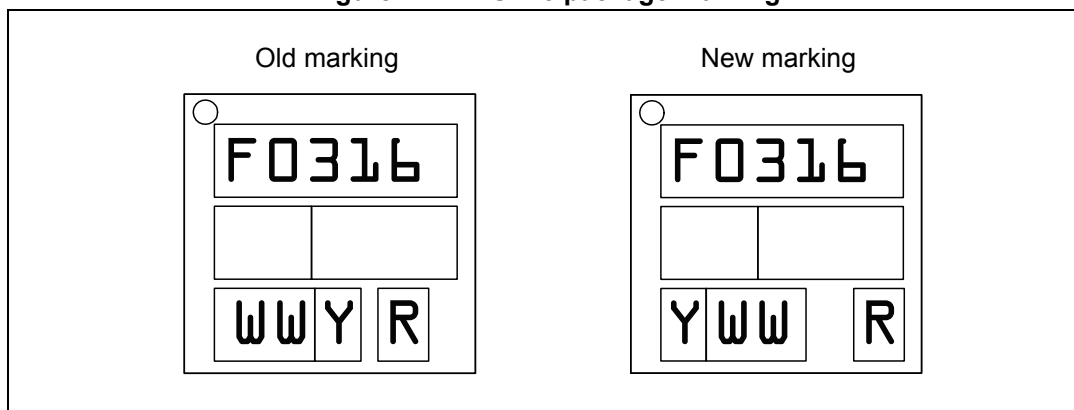
Figure 2. WLCSP25 package marking

From week 9, 2017 on, the marking on the WLCSP25 package is modified to show the date in the format YWW. [Figure 2](#) illustrates the difference between the old and the new product marking. The figure in the product datasheet was also updated to better reflect the dimensions and layout of the marking on the package.
