Applicability

This document applies to the STM32F048C6/G6/T6 devices and their variants shown in [Table 1](#).

Table 1. Device variants

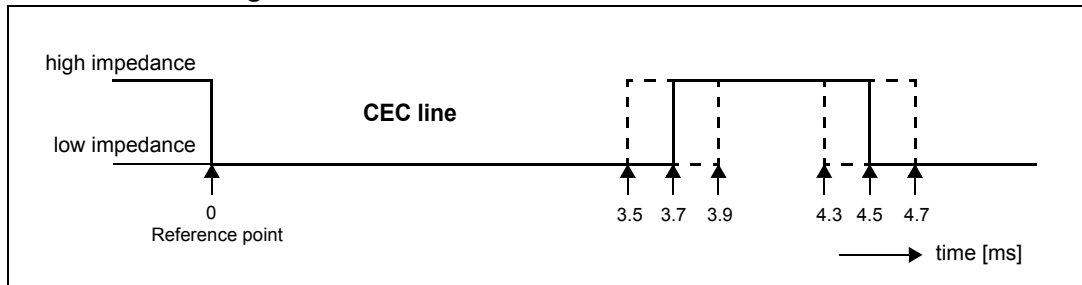
Figure 2. HDMI-CEC start bit format with tolerances

The start bit timing standard tolerances are shown in [Figure 2](#). The start bit is initiated by the device by driving the CEC line low (reference point). After 3.7 ms, the device releases the CEC line and starts checking its level. The following conditions must be met for the start bit to be valid:

If one of these conditions is not met, the transmission is aborted and never automatically retried. No error flag is set and the TXSOM (Tx Start Of Message) bit is not cleared.

The only way to detect this error is for the application software to start a timeout when setting the TXSOM bit, restart it upon ARBLST or any RX event (as the transmission can be delayed by interleaved reception), and stop it upon TXBR (proof that the start bit was transmitted successfully) or TXEND event, or upon any TX error (which clears TXSOM). If the timeout expires (because none of those events occurred), the application software must restart the HDMI-CEC peripheral and retransmit the message.
