Applicability

This document applies to the part numbers of STM32F072x8/xB devices listed in [Table 1](#) and their variants shown in [Table 2](#).

[Section 1](#) gives a summary and [Section 2](#) a description of device limitations, with respect to the device datasheet and reference manual RM0091.

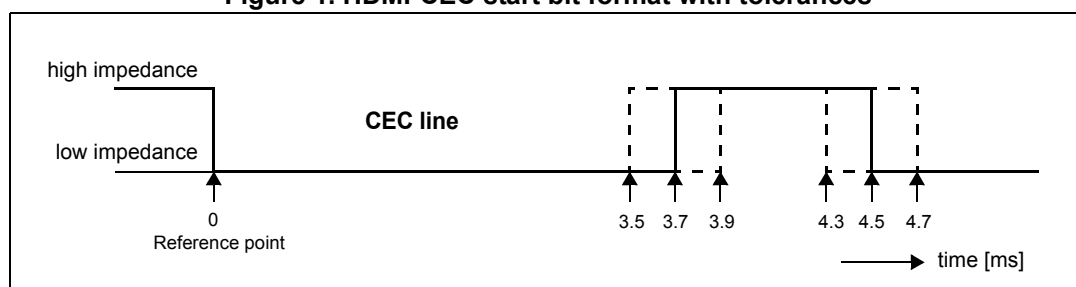
Figure 1. HDMI-CEC start bit format with tolerances

This failure is unlikely to happen as the CEC start bit corruption by another device can only occur if that device does not respect the CEC communication protocol.

The start bit timing standard tolerances are shown in [Figure 1](#). The start bit is initiated by the device by driving the CEC line low (reference point). After 3.7 ms, the device releases the CEC line and starts checking its level. The following conditions must be met for the start bit to be valid:

If one of these conditions is not met, the transmission is aborted and never automatically retried. No error flag is set and the TXSOM (Tx Start Of Message) bit is not cleared.

The only way to detect this error is for the application software to start a timeout when setting the TXSOM bit, restart it upon ARBLST or any RX event (as the transmission can be delayed by interleaved reception), and stop it upon TXBR (proof that the start bit was transmitted successfully) or TXEND event, or upon any TX error (which clears TXSOM). If the timeout expires (because none of those events occurred), the application software must restart the HDMI-CEC peripheral and retransmit the message.
