## STM32F071x8/xB device errata

This document applies to the part numbers of STM32F071x8/xB devices and the device variants as stated in this page.

It gives a summary and a description of the device errata, with respect to the device datasheet and reference manual RM0091.

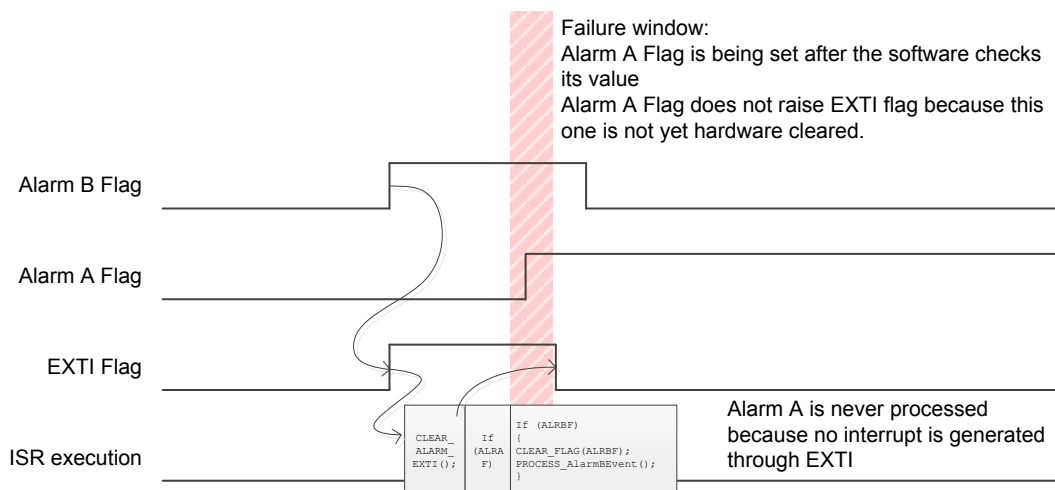
Figure 1. Masked RTC interrupt

The following code example and figure illustrate the failure mechanism: The Alarm A event is lost (fails to generate interrupt) as it occurs in the failure window, that is, after checking the Alarm A event flag but before the effective clear of the EXTI interrupt flag by hardware. The effective clear of the EXTI interrupt flag is delayed with respect to the software instruction to clear it.

In the interrupt service routine, apply three consecutive event flag checks - source one, source two, and source one again, as in the following code example:

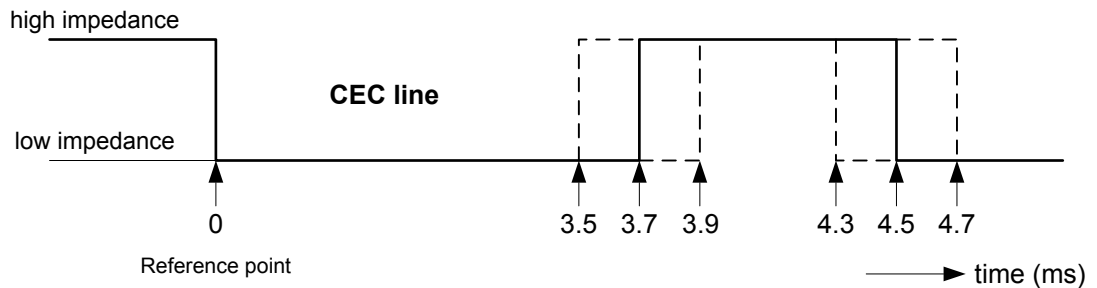
**Figure 2. HDMI-CEC start bit format with tolerances**

The start bit timing standard tolerances are shown in the following figure. The start bit is initiated by the device by driving the CEC line low (reference point). After 3.7 ms, the device releases the CEC line and starts checking its level. The following conditions must be met for the start bit to be valid:

If one of these conditions is not met, the transmission is aborted and never automatically retried. No error flag is set and the TXSOM (Tx start of message) bit is not cleared.

The only way to detect this error is for the application software to start a timeout when setting the TXSOM bit, restart it upon ARBLST or any RX event (as the transmission can be delayed by interleaved reception), and stop it upon TXBR (proof that the start bit was transmitted successfully) or TXEND event, or upon any TX error (which clears TXSOM). If the timeout expires (because none of those events occurred), the application software must restart the HDMI-CEC peripheral and retransmit the message.
