STM32F401xD and STM32F401xE device errata

This document applies to the part numbers of STM32F401xD/E devices and the device variants as stated in this page.

It gives a summary and a description of the device errata, with respect to the device datasheet and reference manual RM0368.

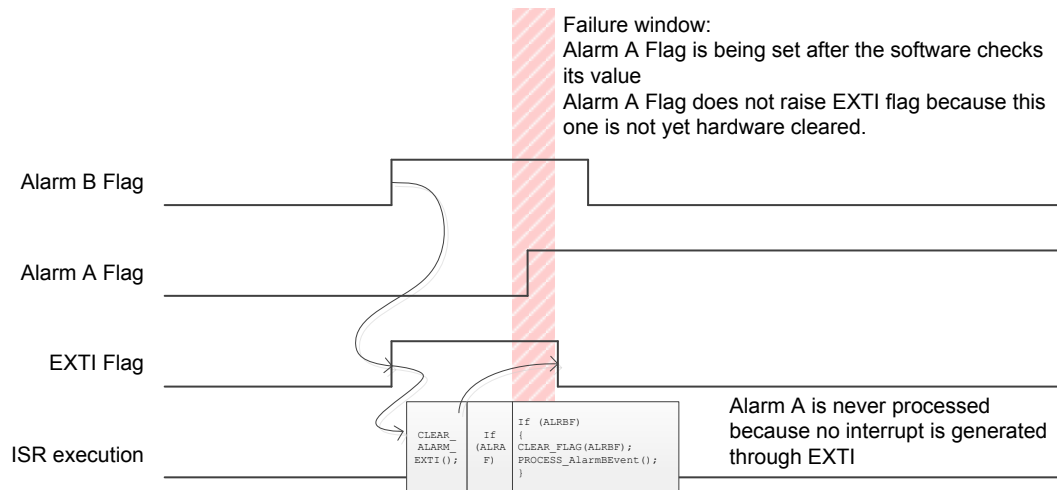
Figure 1. Masked RTC interrupt

The following code example and figure illustrate the failure mechanism: The Alarm A event is lost (fails to generate interrupt) as it occurs in the failure window, that is, after checking the Alarm A event flag but before the effective clear of the EXTI interrupt flag by hardware. The effective clear of the EXTI interrupt flag is delayed with respect to the software instruction to clear it.
