STM32L476xx/STM32L486xx device limitations

This document applies to the part numbers of STM32L476xx and STM32L486xx devices listed in [Table 1](#) and their variants shown in [Table 2](#).

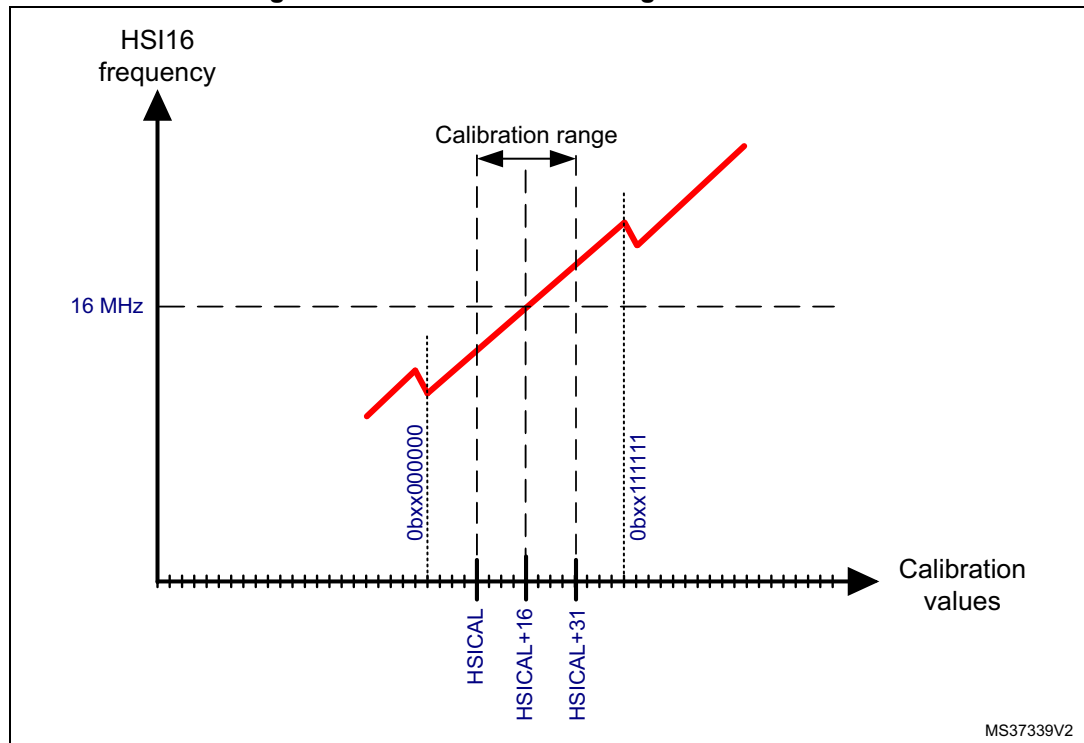
Figure 1. HSI oscillator trimming characteristics

Consequently, the user trim correction must not jump over the codes multiple of 64, which can limit the user correction either in positive or in negative direction.

None.

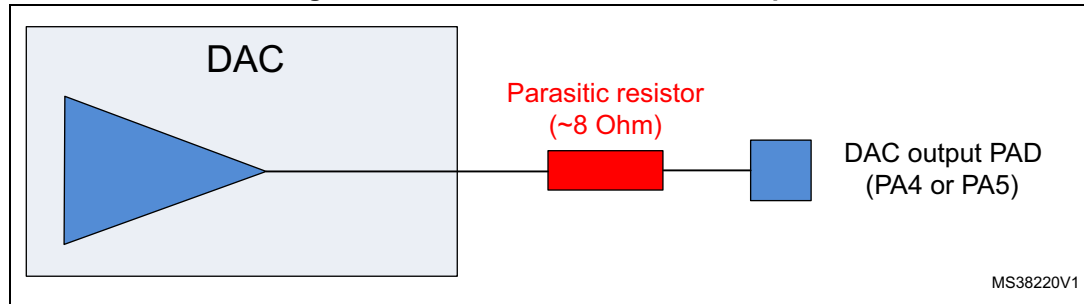
Figure 3. Parasitic resistor on DAC output

Resistor value between DAC outputs and I/O (PA4 or PA5) is greater than expected: 8 Ω typical, as shown in [Figure 3](#). As a consequence, the DAC characteristics can be impacted depending on the current sunk on DAC output.

None.

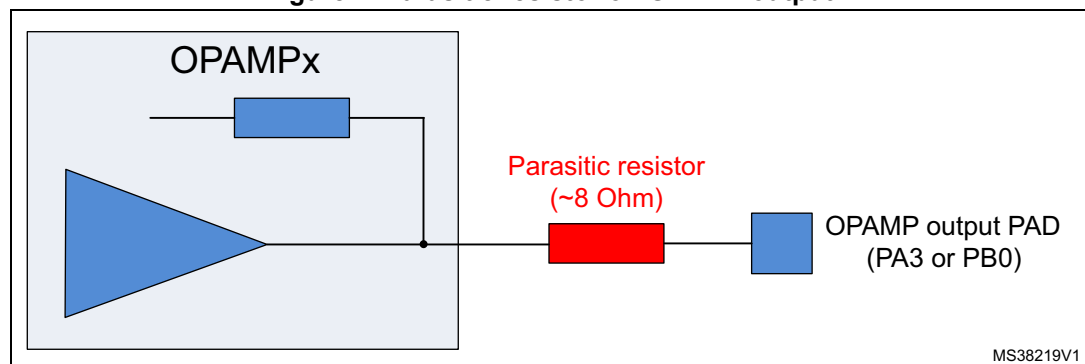
Figure 4. Parasitic resistor on OPAMP output

Resistor value between OPAMP outputs and I/O (PA3 or PB0) is greater than expected: 8 Ω typical, as shown in *Figure 4*. As a consequence the OPAMP characteristics can be impacted depending on the current sunk on the output.

None.

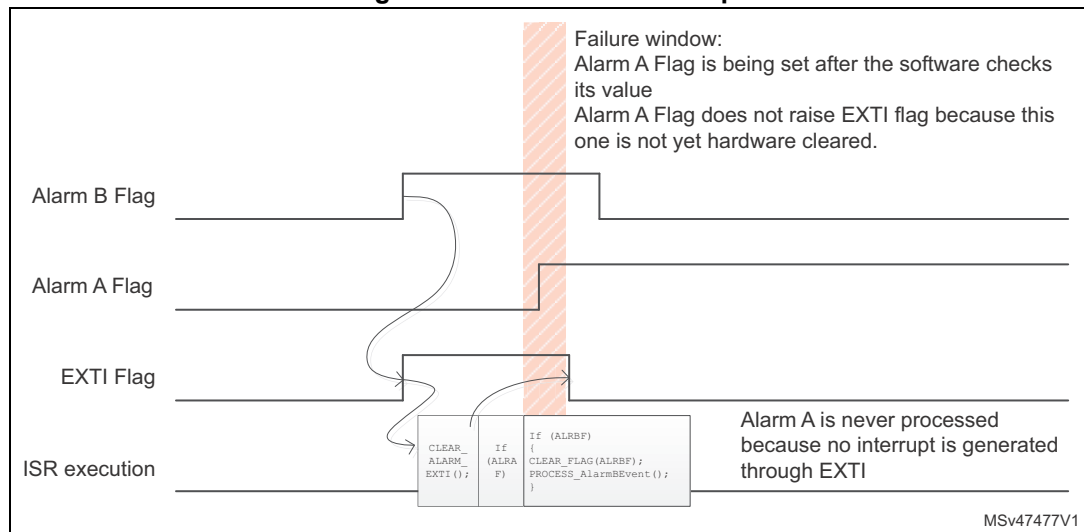
Figure 5. Masked RTC interrupt

The following code example and figure illustrate the failure mechanism: The Alarm A event is lost (fails to generate interrupt) as it occurs in the failure window, that is, after checking the Alarm A event flag but before the effective clear of the EXTI interrupt flag by hardware. The effective clear of the EXTI interrupt flag is delayed with respect to the software instruction to clear it.

In the interrupt service routine, apply three consecutive event flag checks - source one, source two, and source one again, as in the following code example:
