Applicability

This document applies to the part numbers of STM32L476xx and STM32L486xx devices listed in [Table 1](#) and their variants shown in [Table 2](#).

[Section 1](#) gives a summary and [Section 2](#) a description of workarounds for device limitations, with respect to the device datasheet and reference manual RM0351.

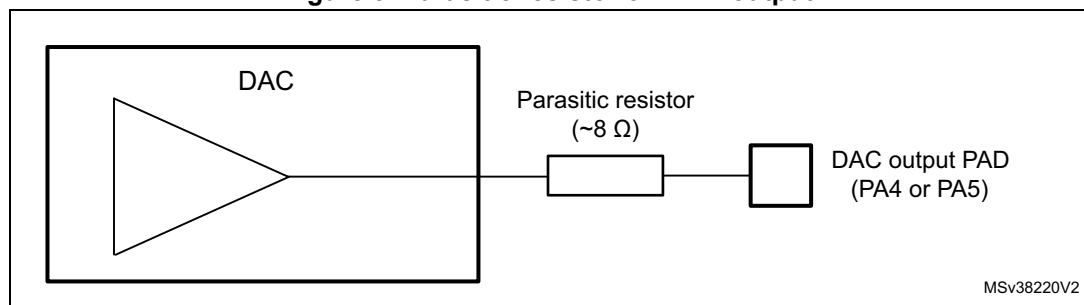
Figure 3. Parasitic resistor on DAC output

Resistor value between DAC outputs and I/O (PA4 or PA5) is greater than expected: 8 Ω typical, as shown in *Figure 3*. As a consequence, the DAC characteristics can be impacted depending on the current sunk on DAC output.

None.

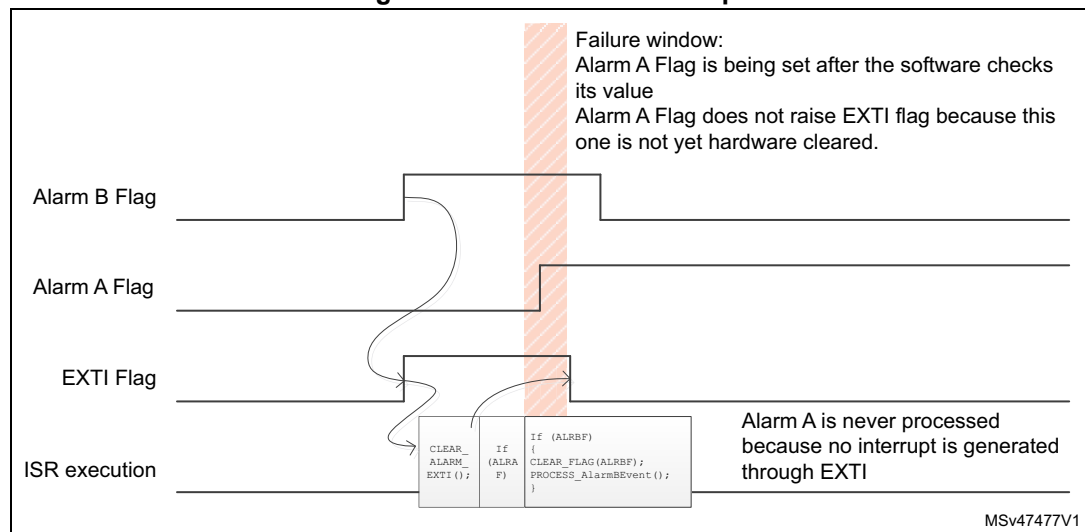
Figure 5. Masked RTC interrupt

The following code example and figure illustrate the failure mechanism: The Alarm A event is lost (fails to generate interrupt) as it occurs in the failure window, that is, after checking the Alarm A event flag but before the effective clear of the EXTI interrupt flag by hardware. The effective clear of the EXTI interrupt flag is delayed with respect to the software instruction to clear it.

In the interrupt service routine, apply three consecutive event flag checks - source one, source two, and source one again, as in the following code example:
