## Applicability

This document applies to the part numbers of STM32F091xB/xC devices listed in [Table 1](#) and their variants shown in [Table 2](#).

[Section 1](#) gives a summary and [Section 2](#) a description of device limitations and documentation errata, with respect to the device datasheet and reference manual RM0091.

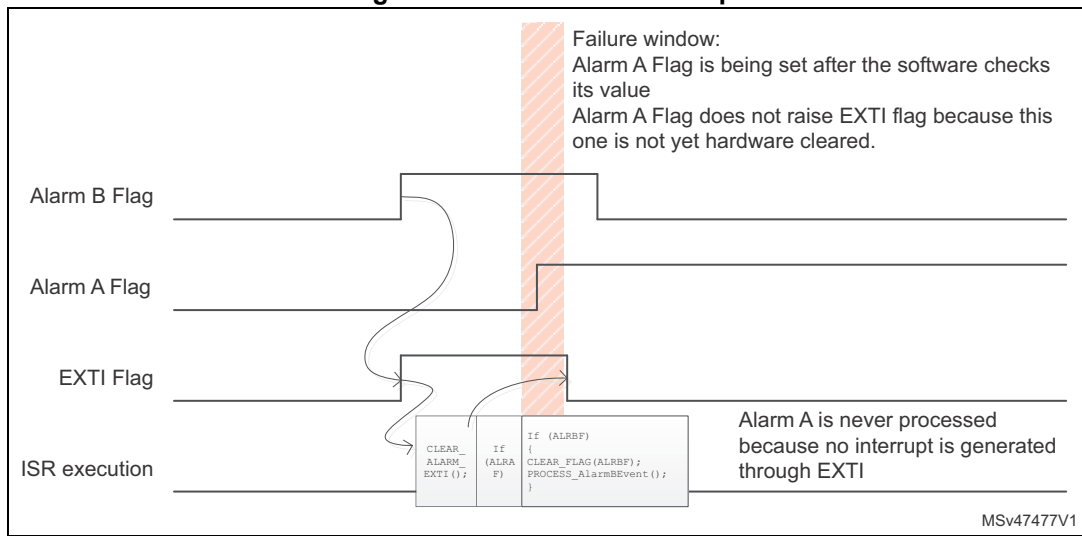
**Figure 1. Masked RTC interrupt**

One RTC interrupt can mask another RTC interrupt if both share the same EXTI configurable line, such as the RTC Alarm A and Alarm B, of which the event flags are OR-ed to the same EXTI line (refer to the **EXTI line connections** table in the **Extended interrupt and event controller (EXTI)** section of the reference manual).

The following code example and figure illustrate the failure mechanism: The Alarm A event is lost (fails to generate interrupt) as it occurs in the failure window, that is, after checking the Alarm A event flag but before the effective clear of the EXTI interrupt flag by hardware. The effective clear of the EXTI interrupt flag is delayed with respect to the software instruction to clear it.

In the interrupt service routine, apply three consecutive event flag checks - source one, source two, and source one again, as in the following code example:

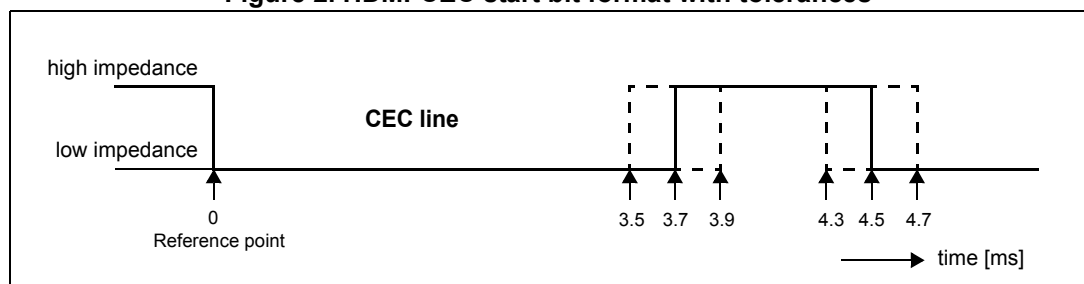
**Figure 2. HDMI-CEC start bit format with tolerances**

This failure is unlikely to happen as the CEC start bit corruption by another device can only occur if that device does not respect the CEC communication protocol.

The start bit timing standard tolerances are shown in [Figure 2](#). The start bit is initiated by the device by driving the CEC line low (reference point). After 3.7 ms, the device releases the CEC line and starts checking its level. The following conditions must be met for the start bit to be valid:

If one of these conditions is not met, the transmission is aborted and never automatically retried. No error flag is set and the TXSOM (Tx Start Of Message) bit is not cleared.

The only way to detect this error is for the application software to start a timeout when setting the TXSOM bit, restart it upon ARBLST or any RX event (as the transmission can be
