## STM32F100xC, STM32F100xD and STM32F100xE high-density value line device limitations

This errata sheet applies to the revision A of the STMicroelectronics high-density value line products.

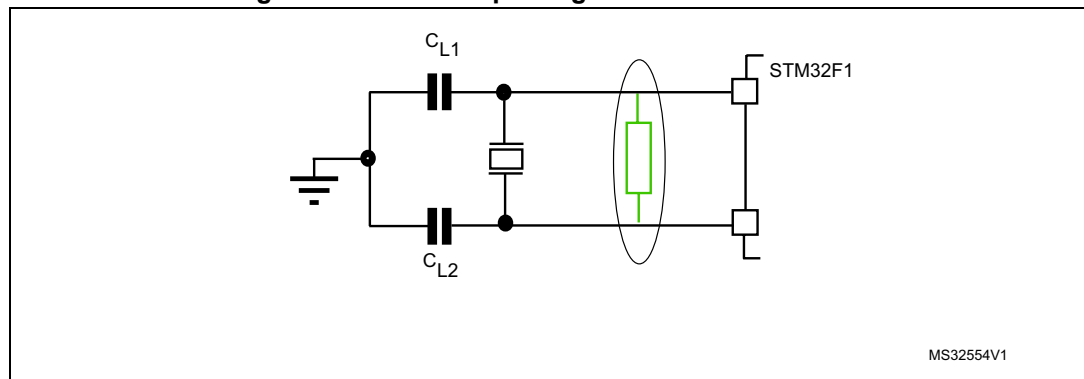
Figure 1. LSE start-up using an additional resistor

The LSE (Low Speed External) oscillator system is designed to minimize the overall power consumption of the STM32F1 microcontroller. It is extremely important to take specific care in the design of the PCB to ensure this low power oscillator starts in harsh conditions. In some PCB designs without coating, an induced low leakage may prevent the LSE to start-up, regardless of the 32.768 KHz crystal used. This phenomenon is amplified in humid environments that create frost on the OSC32\_IN/OSC32\_OUT tracks. This unwanted behavior may happen only at the first back-up domain power-on of the device.

It is recommended to mount an additional parallel feedback resistor (from 16 M $\Omega$  to 22 M $\Omega$ ) on board to help the oscillation start-up in all cases (see [Figure 1](#)). For more details on compatible crystals and hardware techniques on PCB, refer to AN2867 application note.
