## STM8S001J3, STM8S003xx, STM8S103xx and STM8S903xx device limitations

### Silicon identification

This errata sheet applies to the STMicroelectronics STM8S001J3, STM8S003xx, STM8S103xx and STM8S903xx devices.

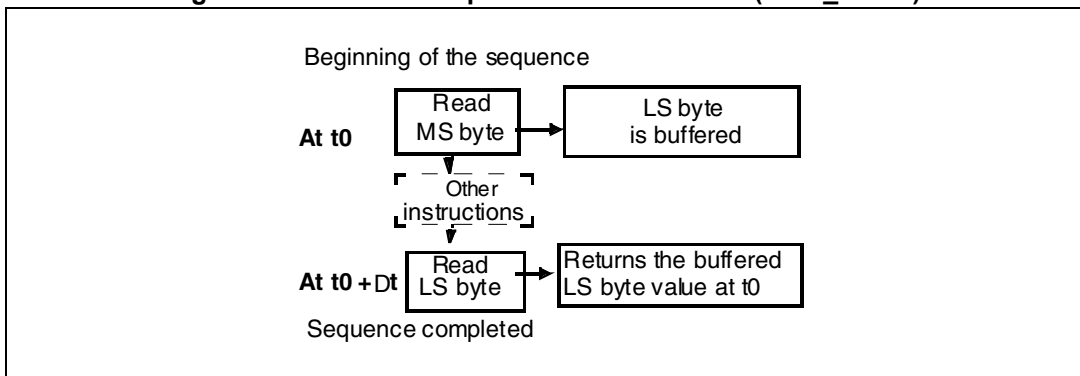
**Figure 1. 16-bit read sequence for the counter (TIMx\_CNTR)**

**2.4.1 Corruption of read sequence for the 16-bit counter registers**

An 8-bit buffer is implemented for reading the 16-bit counter registers. Software must read the MS byte first, after which the LS byte value is buffered automatically (see *Figure 1*). This buffered value remains unchanged until the 16-bit read sequence is completed.

When any multi-cycle instruction precedes the read of the LSB, the content of the buffer is lost and the second read returns the immediate content of the counter directly.

Do not use multi-cycle instructions before reading the LSB.
