Silicon identification

This errata sheet applies to the revision A or 1 of the STMicroelectronics STM32F101xF/G access line and STM32F103xF/G performance line XL-density products. These families feature an ARM® 32-bit Cortex®-M3 core, for which an errata notice is also available (see [Section 1](#) for details).

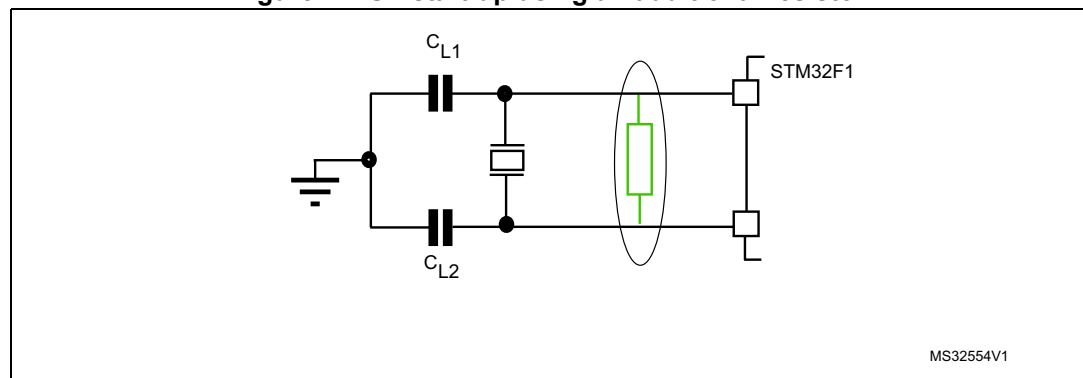
Figure 1. LSE start-up using an additional resistor

The LSE (Low Speed External) oscillator system has been designed to minimize the overall power consumption of the STM32F1 microcontroller. It is extremely important to take specific care in the design of the PCB to ensure this low power oscillator starts in harsh conditions. In some PCB designs without coating, an induced low leakage may prevent the LSE to start-up, regardless of the 32.768 KHz crystal used. This phenomenon is amplified in humid environments that create frost on the OSC32_IN/OSC32_OUT tracks. This unwanted behavior may happen only at the first back-up domain power-on of the device.

It is recommended to mount an additional parallel feedback resistor (from 16 M Ω to 22 M Ω) on board to help the oscillation start-up in all cases (see [Figure 1](#)). For more details on compatible crystals and hardware techniques on PCB, refer to AN2867 application note.
