STM8S005xx and STM8S105xx device limitations

Silicon identification

This errata sheet applies to revision X/7 of STM8S005xx product and revisions Z, Y/6, X/7 of STM8S105xx products. A full list of root part numbers is shown in [Table 2](#).

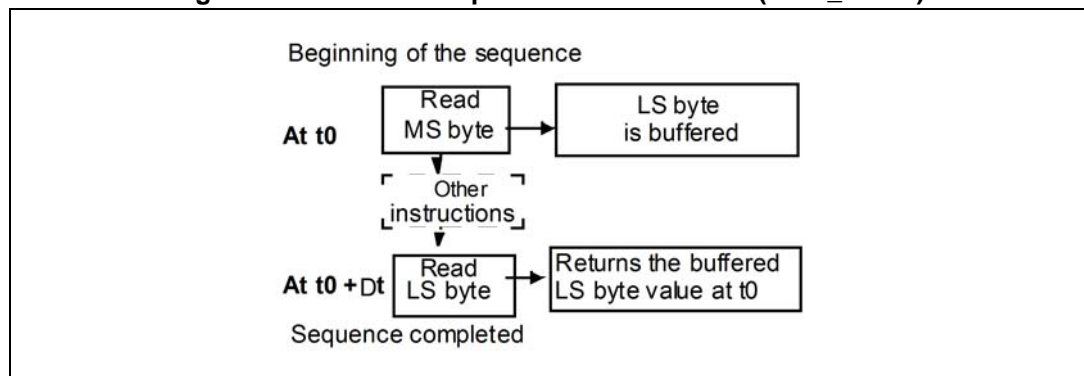
Figure 1. 16-bit read sequence for the counter (TIMx_CNTR)

An 8-bit buffer is implemented for reading the 16-bit counter registers. The software must read the MS byte first, after which the LS byte value is buffered automatically (see [Figure 1](#)). This buffered value remains unchanged until the 16-bit read sequence is completed.

When any multi-cycle instruction precedes the read of the LSB, the content of the buffer is lost and the second read returns the immediate content of the counter directly.

Do not use multi-cycle instructions before reading the LSB.
