STM32F101xC/D/E and STM32F103xC/D/E high-density device limitations

Silicon identification

This errata sheet applies to the revisions Z, Y, 1, 2, 3 and X of the STMicroelectronics STM32F101xC/D/E access line and STM32F103xC/D/E performance line high-density products. These families feature an ARM® 32-bit Cortex®-M3 core, for which an errata notice is also available (see [Section 1](#) for details).

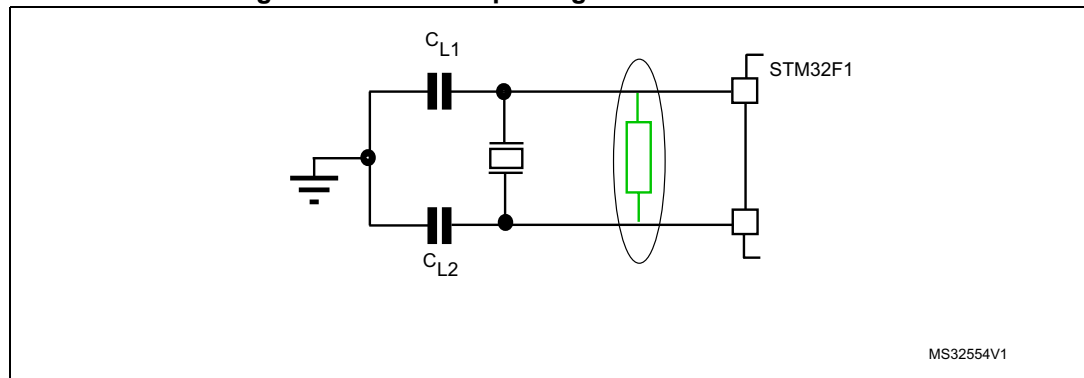
Figure 1. LSE start-up using an additional resistor

The LSE (Low Speed External) oscillator system has been designed to minimize the overall power consumption of the STM32F1 microcontroller. It is extremely important to take specific care in the design of the PCB to ensure this low power oscillator starts in harsh conditions. In some PCB designs without coating, an induced low leakage may prevent the LSE to start-up, regardless of the 32.768 KHz crystal used. This phenomenon is amplified in humid environments that create frost on the OSC32_IN/OSC32_OUT tracks. This unwanted behavior may happen only at the first back-up domain power-on of the device.

It is recommended to mount an additional parallel feedback resistor (from 16 MΩ to 22 MΩ) on board to help the oscillation start-up in all cases (see [Figure 1](#)). For more details on compatible crystals and hardware techniques on PCB, refer to AN2867 application note.
