STM32F101xC/D/E and STM32F103xC/D/E high-density device limitations

This errata sheet applies to the revisions Z, Y, 1, 2, 3 and X of the STMicroelectronics STM32F101xC/D/E access line and STM32F103xC/D/E performance line high-density products. These families feature an ARM® 32-bit Cortex®-M3 core, for which an errata notice is also available (see [Section 1](#) for details).

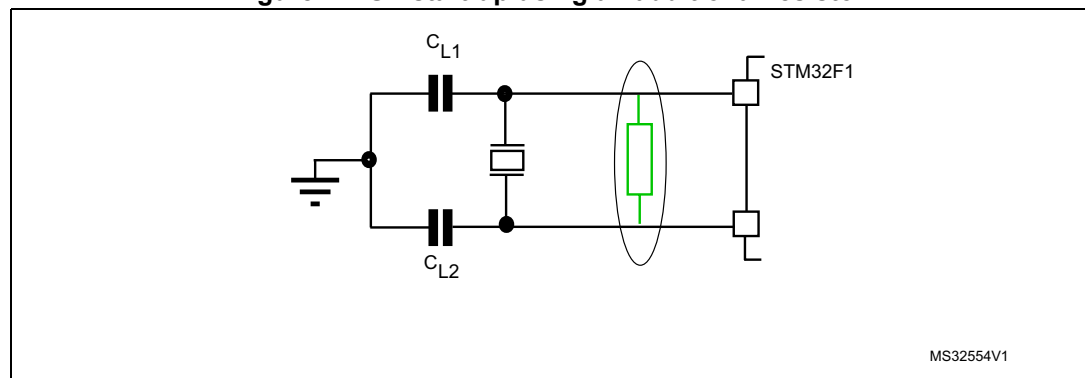
Figure 1. LSE start-up using an additional resistor

The LSE (Low Speed External) oscillator system has been designed to minimize the overall power consumption of the STM32F1 microcontroller. It is extremely important to take specific care in the design of the PCB to ensure this low power oscillator starts in harsh conditions. In some PCB designs without coating, an induced low leakage may prevent the LSE to start-up, regardless of the 32.768 KHz crystal used. This phenomenon is amplified in humid environments that create frost on the OSC32_IN/OSC32_OUT tracks. This unwanted behavior may happen only at the first back-up domain power-on of the device.

It is recommended to mount an additional parallel feedback resistor (from 16 M Ω to 22 M Ω) on board to help the oscillation start-up in all cases (see [Figure 1](#)). For more details on compatible crystals and hardware techniques on PCB, refer to AN2867 application note.
