STM32F76xxx/77xxx device errata

Applicability

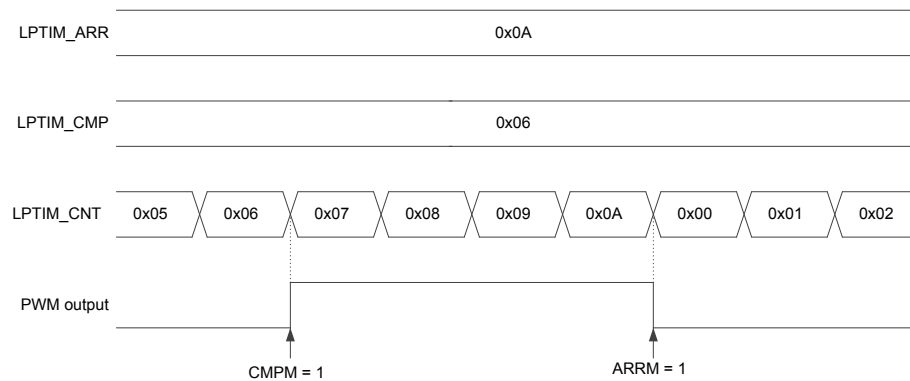
Consequently, it is not possible to generate PWM with a duty cycle of 0% or 100%.

The following waveform gives the example of PWM output mode and the effect of the delay:

Set the compare value to the desired value minus 1. For instance in order to generate a compare match when LPTM_CNT = 0x08, set the compare value to 0x07.

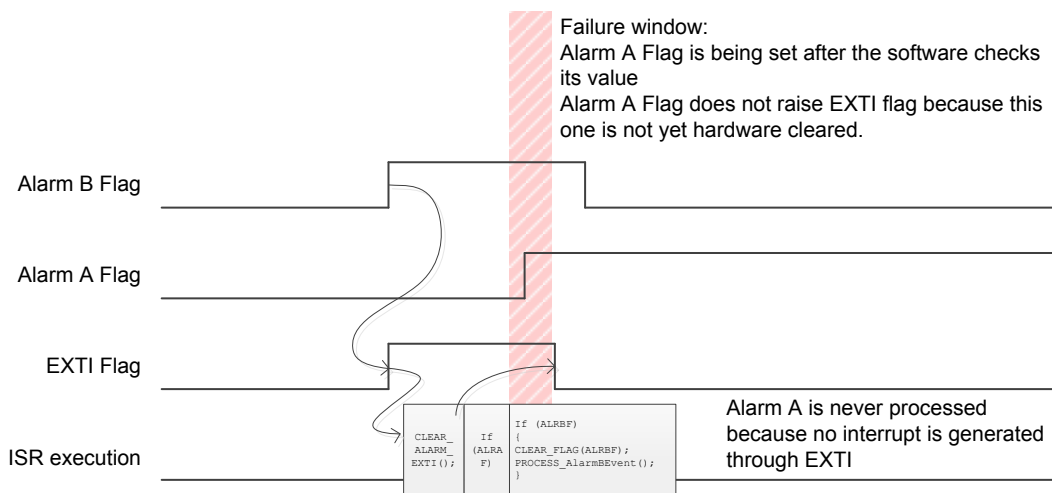
Figure 1. Masked RTC interrupt

The following code example and figure illustrate the failure mechanism: The Alarm A event is lost (fails to generate interrupt) as it occurs in the failure window, that is, after checking the Alarm A event flag but before the effective clear of the EXTI interrupt flag by hardware. The effective clear of the EXTI interrupt flag is delayed with respect to the software instruction to clear it.

In the interrupt service routine, apply three consecutive event flag checks - source one, source two, and source one again, as in the following code example:
