## The BlueNRG-2 device limitations

### Silicon identification

This errata sheet applies to the following STMicroelectronics BlueNRG-2 devices:

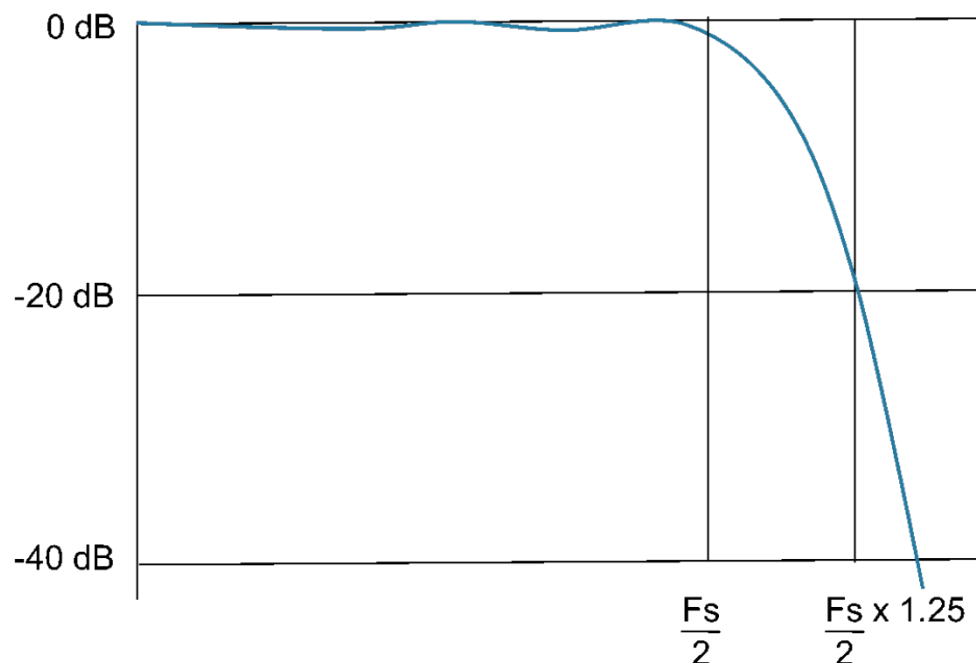
Figure 1. Interpolation filter frequency response

## 1.9 ADC unwanted aliased signal after decimation filter

**Description:** the bandwidth of the anti-aliasing filter is slightly broader with respect to the signal bandwidth, potentially thus generating unwanted aliased signal after the decimation filter.

**Impact:** When a pure sine wave, generated in the  $[\frac{Fs}{2}; 1.25 \cdot \frac{Fs}{2}]$  range, is being sampled, user can notice an attenuated aliased sine wave in the  $[0.75 \cdot \frac{Fs}{2}; \frac{Fs}{2}]$  range.

In case of waveform acquisition, especially when audio speech and music is caught, no further degradation has been identified.

$F_s$  is the sampling frequency on the output of the downsampling filter, described as ADC data rate in the datasheet.

**Workaround:** by choosing an appropriate oversampling factor (OSR), so that maximum frequency of the sampled signal is lower than  $F_s/2$ , aliasing may be avoided.
