STM32L496xx and STM32L4A6xx device limitations

This document applies to the part numbers of STM32L496xx and STM32L4A6xx devices listed in [Table 1](#) and their variants shown in [Table 2](#).

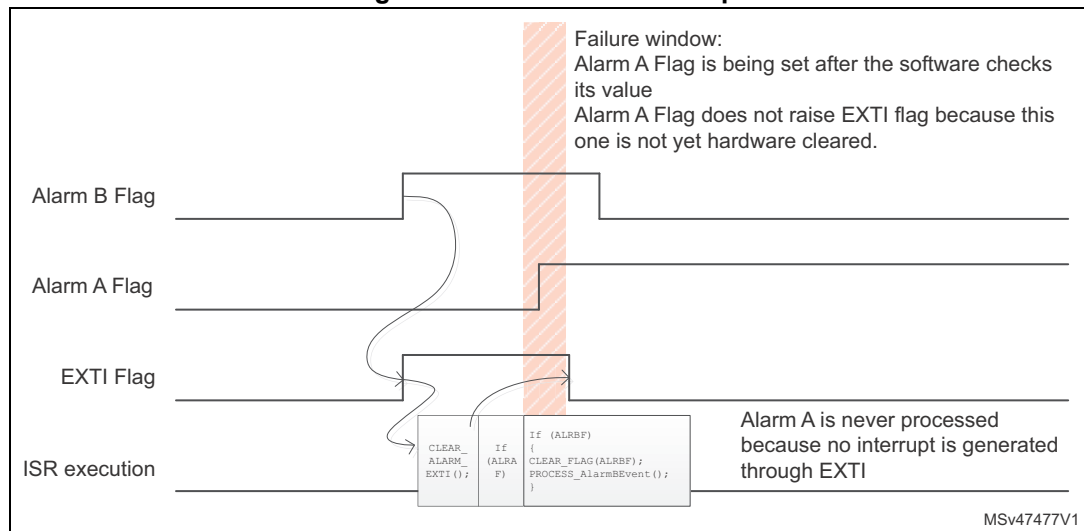
Figure 1. Masked RTC interrupt

The following code example and figure illustrate the failure mechanism: The Alarm A event is lost (fails to generate interrupt) as it occurs in the failure window, that is, after checking the Alarm A event flag but before the effective clear of the EXTI interrupt flag by hardware. The

Workaround

In the interrupt service routine, apply three consecutive event flag checks - source one, source two, and source one again, as in the following code example:
