## STM32L462CE/RE/VE device errata

This document applies to the part numbers of STM32L462CE/RE/VE devices and the device variants as stated in this page. It gives a summary and a description of the device errata, with respect to the device datasheet and reference manual RM0394. Deviation of the real device behavior from the intended device behavior is considered to be a device limitation. Deviation of the description in the reference manual or the datasheet from the intended device behavior is considered to be a documentation erratum. The term “*errata*” applies both to limitations and documentation errata.

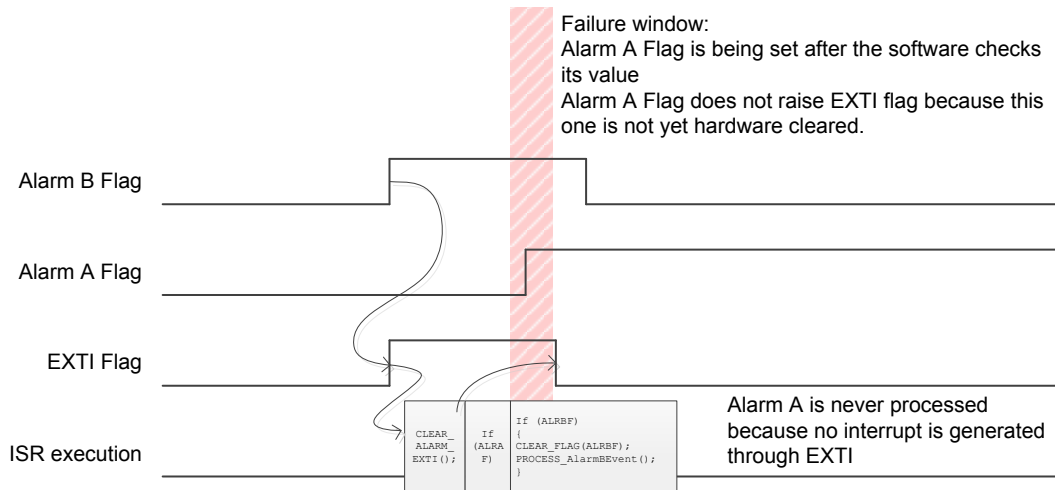
**Figure 1. Masked RTC interrupt**

The following code example and figure illustrate the failure mechanism: The Alarm A event is lost (fails to generate interrupt) as it occurs in the failure window, that is, after checking the Alarm A event flag but before the effective clear of the EXTI interrupt flag by hardware. The effective clear of the EXTI interrupt flag is delayed with respect to the software instruction to clear it.

In the interrupt service routine, apply three consecutive event flag checks - source one, source two, and source one again, as in the following code example:
