STM32L431xx device errata

This document applies to the part numbers of STM32L431xx devices and the device variants as stated in this page.

It gives a summary and a description of the device errata, with respect to the device datasheet and reference manual RM394.

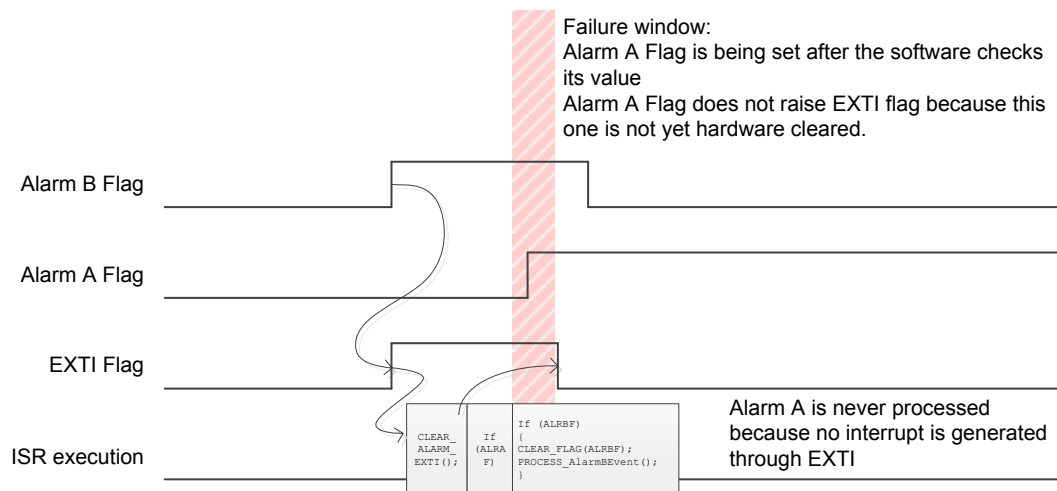
Figure 1. Masked RTC interrupt

The following code example and figure illustrate the failure mechanism: The Alarm A event is lost (fails to generate interrupt) as it occurs in the failure window, that is, after checking the Alarm A event flag but before the effective clear of the EXTI interrupt flag by hardware. The effective clear of the EXTI interrupt flag is delayed with respect to the software instruction to clear it.

In the interrupt service routine, apply three consecutive event flag checks - source one, source two, and source one again, as in the following code example:
