STM32L433xx/443xx device errata

Applicability

This document applies to the part numbers of STM32L433xx/443xx devices and the device variants as stated in this page. It gives a summary and a description of the device errata, with respect to the device datasheet and reference manual RM394. Deviation of the real device behavior from the intended device behavior is considered to be a device limitation. Deviation of the description in the reference manual or the datasheet from the intended device behavior is considered to be a documentation erratum. The term “*errata*” applies both to limitations and documentation errata.

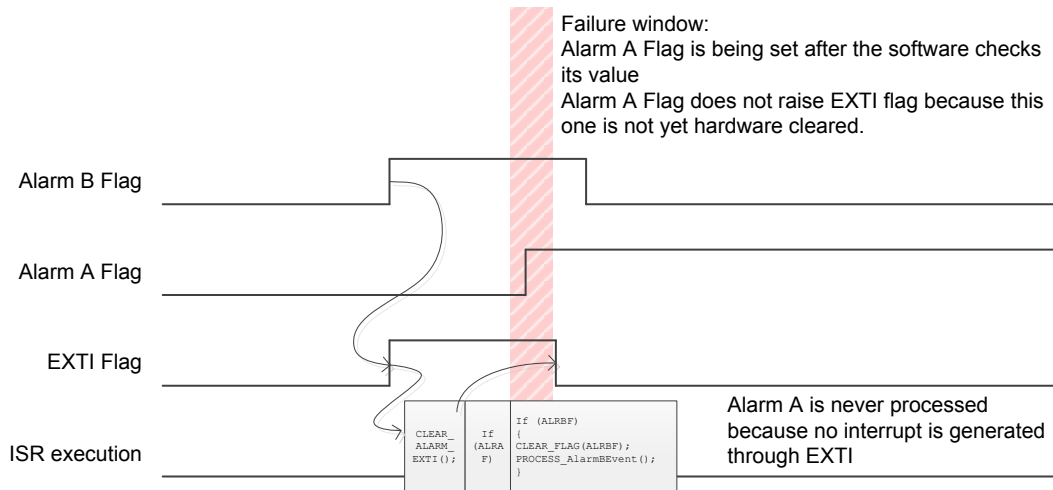
Figure 1. Masked RTC interrupt

The following code example and figure illustrate the failure mechanism: The Alarm A event is lost (fails to generate interrupt) as it occurs in the failure window, that is, after checking the Alarm A event flag but before the effective clear of the EXTI interrupt flag by hardware. The effective clear of the EXTI interrupt flag is delayed with respect to the software instruction to clear it.

Workaround

In the interrupt service routine, apply three consecutive event flag checks - source one, source two, and source one again, as in the following code example:
