STM32L452xx device errata

This document applies to the part numbers of STM32L452xx devices and the device variants as stated in this page.

It gives a summary and a description of the device errata, with respect to the device datasheet and reference manual RM0394.

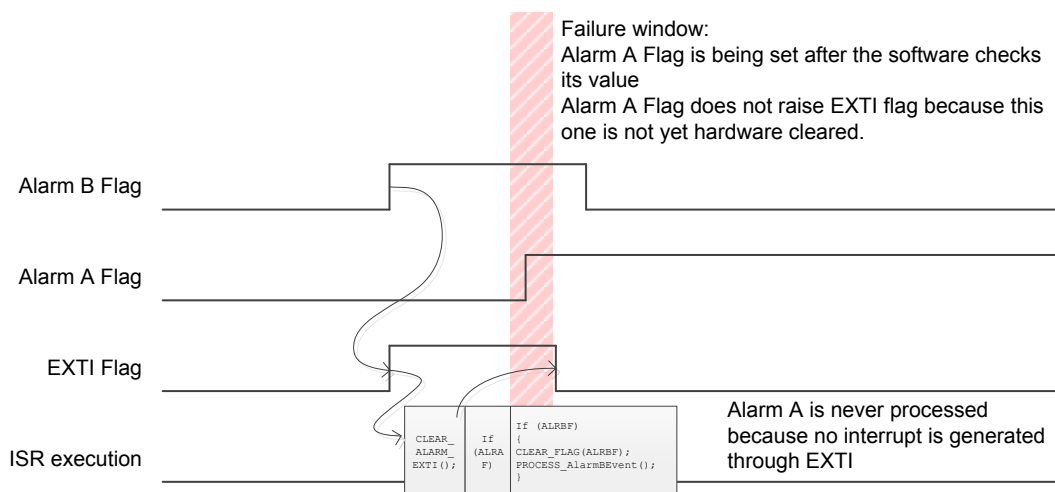
Figure 1. Masked RTC interrupt

The following code example and figure illustrate the failure mechanism: The Alarm A event is lost (fails to generate interrupt) as it occurs in the failure window, that is, after checking the Alarm A event flag but before the effective clear of the EXTI interrupt flag by hardware. The effective clear of the EXTI interrupt flag is delayed with respect to the software instruction to clear it.

Workaround

In the interrupt service routine, apply three consecutive event flag checks - source one, source two, and source one again, as in the following code example:
