AN1363

Application Note

Workaround to ISP Mode Limitation on the ST7MDT1-DVP2 and ST7MDT2-DVP2

by Microcontroller Cores and Tools Division

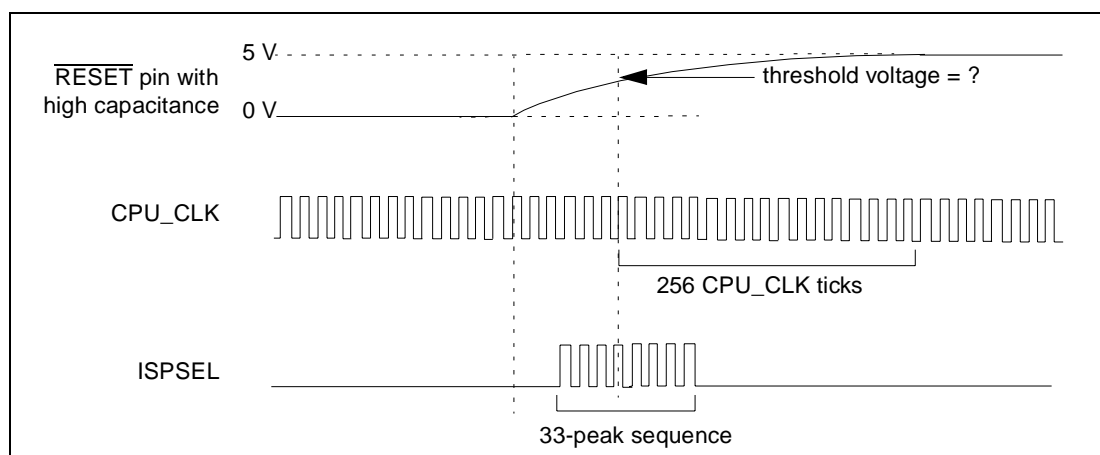
Figure 2: Signal transmission when $\overline{\text{RESET}}$ pin has high capacitance

The problem arises when (for various worthy reasons) you have designed your application board with protections that result in a high capacitance at the target MCU's $\overline{\text{RESET}}$ pin. The result is that following a chip reset, the return of the pin to 5 V can be very gradual, rather than instantaneous.

As the voltage gradually rises at the $\overline{\text{RESET}}$ pin, at some unknown threshold voltage (probably in the vicinity of 3.5 V, but this is dependent on several factors), the target MCU begins to count out 256 CPU_CLK timer ticks, during which time the MCU is “listening” for the ISPSEL signal.

However, because the ISPSEL signal sequence is sent from the ISP driver independently of the $\overline{\text{RESET}}$ pin value, in a high capacitance scenario it becomes very likely that the 33-peak ISPSEL signal sequence will begin transmission before the MCU is ready to receive it (i.e. before the voltage on the $\overline{\text{RESET}}$ pin has reached its threshold value). [Figure 2](#) illustrates this sequence of events.

The result is that the target MCU doesn't receive the ISPSEL signal sequence in its entirety and therefore cannot be put into ISP mode to accept programming.

The first way to ensure that ISP mode functions correctly is to design your application board so that the RESET pin has low capacitance.

- 1 Updating your version of WINEE (Windows Epromer) to version 4.0.
- 2 Modification to the DVP hardware—linking several pins of the ISP driver chip together by soldering two wires.
- 3 Reprogramming the ISP driver firmware.

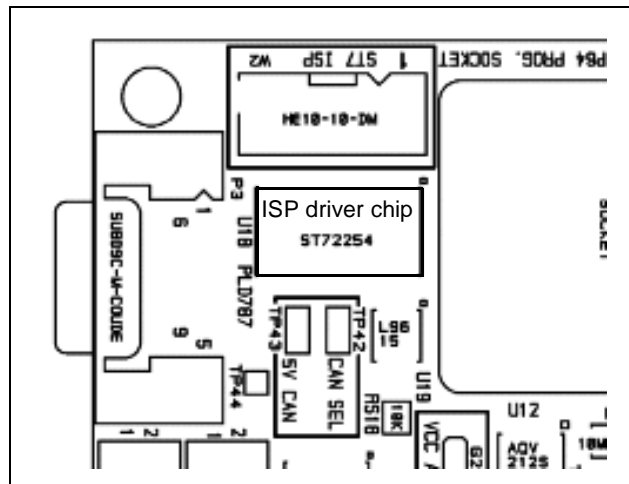
Figure 3: Location of ISP driver chip on the ST7MDT2-DVP2

- 1 Locate the ISP driver chip (ST72254), in the corner of the DVP board, close to the ISP connector. [Figure 3](#) shows the location of the driver chip (labelled U18) for the ST7MDT2-DVP2. The driver chip is in a similar location (labelled U17) on the ST7MDT1-DVP2.

- 2 Once you have located the ST72254 ISP driver chip, find pin 1 of the chip which is indicated by an indentation in the top of the chip's package.
- 3 Solder the following pins together:
 - Pins 8, 9, 10, 11
 - Pins 15, 16, 17, 18
