## Rev B and D limitations and corrections

### Silicon identification

This errata document covers the first group with rev B and rev D.

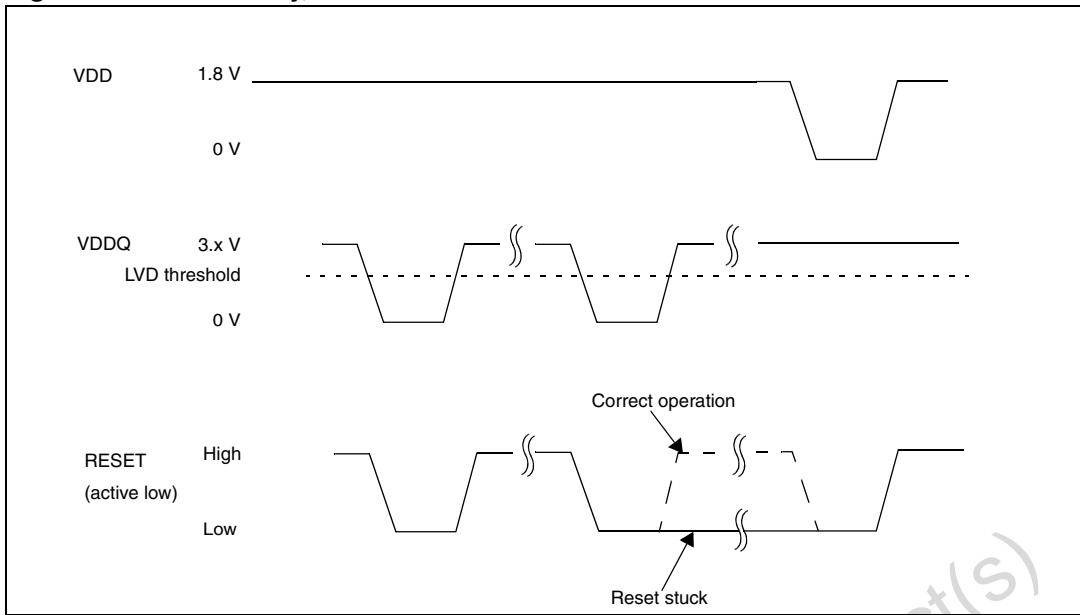
Figure 4. VDD steady, VDDQ falls below its LVD threshold

*Figure 4* illustrates the first case, when VDD is steady, but VDDQ falls below its LVD threshold. You'll see that the generated reset signal during the first drop of VDDQ is correct, and the reset is correctly deactivated when VDDQ returns to normal voltage. However, the second, and subsequent drops, of VDDQ will cause an active reset which remains active even after VDDQ returns to normal level. Only after VDD voltage goes through a power cycle will the reset signal deactivate.

An external reset supervisor device can be used to drive the RESET\_INn input pin on the STR9. The LVD must be switched off in this case. This limitation will be fixed in the STR91xFA series.

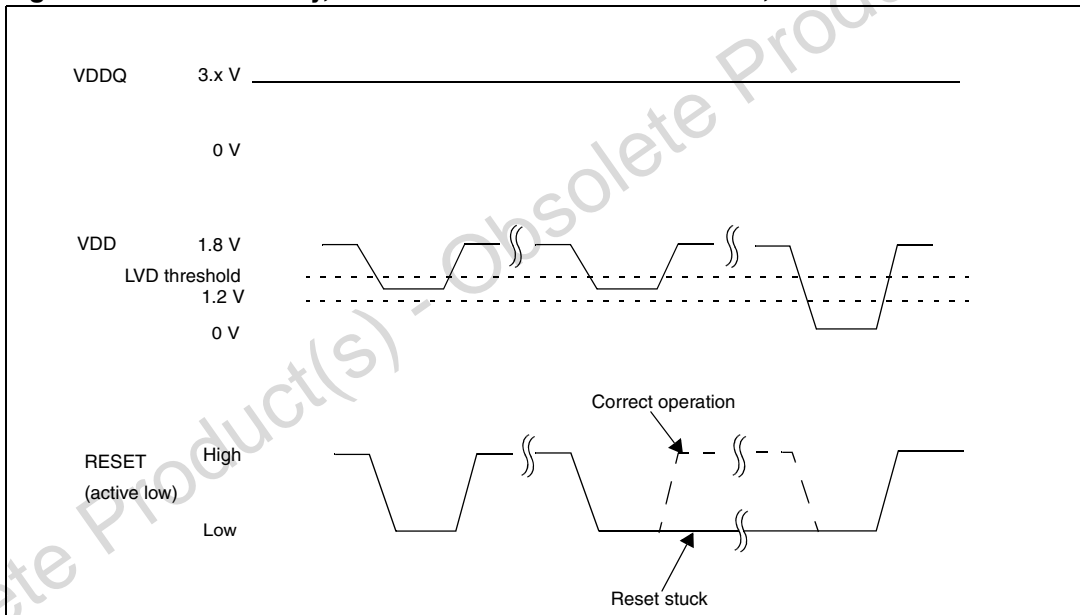
Figure 5. VDDQ steady, VDD falls below its LVD threshold, but not below 1.2 V

*Figure 5* illustrates the second case, when VDDQ is steady, but VDD falls below its LVD level, but not below 1.2 V (power-on-reset level). You'll see that the generated reset signal during the first drop of VDD is correct, but the second and subsequent drops of VDD will cause an active reset which remains active even after VDD returns to normal level. Only after VDD voltage goes through a power cycle (drops below 1.2 V) will the reset signal deactivate.
