## STM32F101xC/D/E, STM32F103xC/D/E device errata

### Applicability

This document applies to the part numbers of STM32F101xC/D/E, STM32F103xC/D/E devices and the device variants as stated in this page.

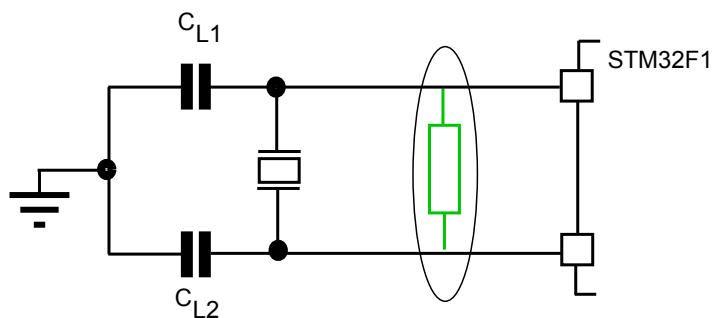
Figure 1. LSE startup using an additional resistor

The LSE (low-speed external) oscillator system has been designed to minimize the overall power consumption of the microcontroller. It is extremely important to take specific care in the design of the PCB to ensure this low power oscillator starts in harsh conditions. In some PCB designs without coating, an induced low leakage may prevent the LSE to startup, regardless of the 32.768 KHz crystal used. This phenomenon is amplified in humid environments that create frost on the OSC32\_IN/OSC32\_OUT tracks. This unwanted behavior may happen only at the first back-up domain power-on of the device.

It is recommended to mount an additional parallel feedback resistor (from 16 M $\Omega$  to 22 M $\Omega$ ) on board to help the oscillation startup in all cases (see [Figure 1](#)). For more details on compatible crystals and hardware techniques on PCB, refer to application note *Oscillator design guide for STM8AF/AL/S, STM32 MCUs and MPUs* (AN2867).
