STM32F101xC/D/E and STM32F103xC/D/E high-density device limitations

This errata sheet applies to the revisions Z, Y, 1, 2, 3 and X of the STMicroelectronics STM32F101xC/D/E access line and STM32F103xC/D/E performance line high-density products. These families feature an Arm® 32-bit Cortex®-M3 core, for which an errata notice is also available (see [Section 1](#) for details).

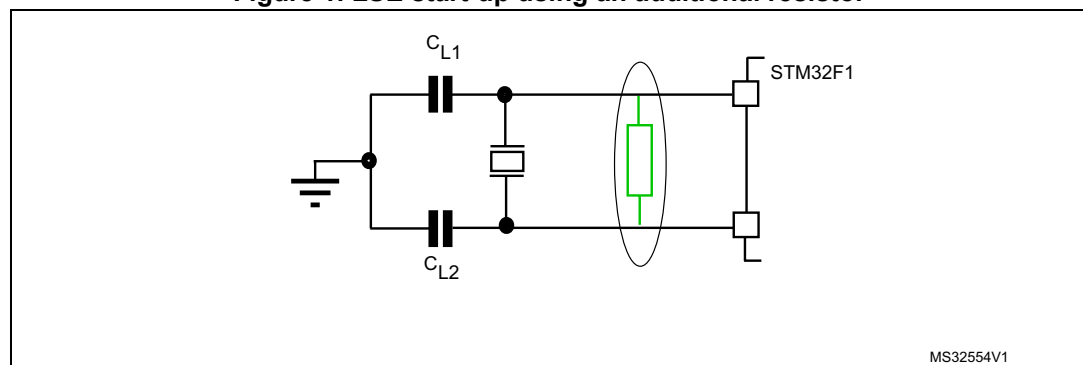
Figure 1. LSE start-up using an additional resistor

The LSE (Low Speed External) oscillator system has been designed to minimize the overall power consumption of the STM32F1 microcontroller. It is extremely important to take specific care in the design of the PCB to ensure this low power oscillator starts in harsh conditions. In some PCB designs without coating, an induced low leakage may prevent the LSE to start-up, regardless of the 32.768 KHz crystal used. This phenomenon is amplified in humid environments that create frost on the OSC32_IN/OSC32_OUT tracks. This unwanted behavior may happen only at the first back-up domain power-on of the device.

It is recommended to mount an additional parallel feedback resistor (from 16 MΩ to 22 MΩ) on board to help the oscillation start-up in all cases (see [Figure 1](#)). For more details on compatible crystals and hardware techniques on PCB refer to AN2867 “Oscillator design guide for STM8AF/AL/S, STM32 MCUs and MPUs” available on www.st.com.
