## STM32F101x4/6, STM32F102x4/6 and STM32F103x4/6 low-density device limitations

### Silicon identification

This errata sheet applies to the revision A of the STMicroelectronics low-density STM32F101xx access line, STM32F102xx USB access line and STM32F103xx performance line products. These families feature an Arm® 32-bit Cortex®-M3 core, for which an errata notice is also available (see [Section 1](#) for details).

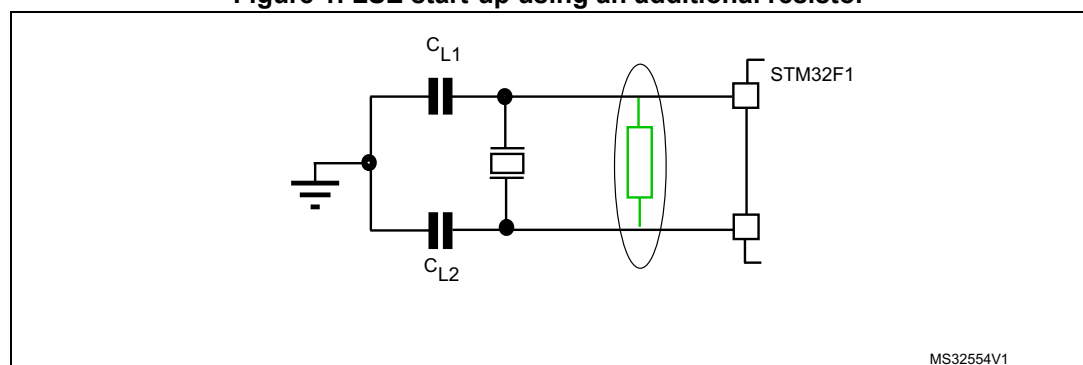
Figure 1. LSE start-up using an additional resistor

The LSE (Low Speed External) oscillator system has been designed to minimize the overall power consumption of the STM32F1 microcontroller. It is extremely important to take specific care in the design of the PCB to ensure this low power oscillator starts in harsh conditions. In some PCB designs without coating, an induced low leakage may prevent the LSE to start-up, regardless of the 32.768 KHz crystal used. This phenomenon is amplified in humid environments that create frost on the OSC32\_IN/OSC32\_OUT tracks. This unwanted behavior may happen only at the first back-up domain power-on of the device.

It is recommended to mount an additional parallel feedback resistor (from 16 M $\Omega$  to 22 M $\Omega$ ) on board to help the oscillation start-up in all cases (see [Figure 1](#)). For more details on compatible crystals and hardware techniques on PCB, refer to AN2867 "Oscillator design guide for STM8AF/AL/S, STM32 MCUs and MPUs" available on [www.st.com](http://www.st.com).
