STM32F105xx and STM32F107xx revision Z connectivity line device limitations

This errata sheet applies to the revision Z of the STMicroelectronics STM32F105xx and STM32F107xx connectivity line products. This family features an Arm[®] 32-bit Cortex[®]-M3 core, for which an errata notice is also available (see [Section 1](#) for details).

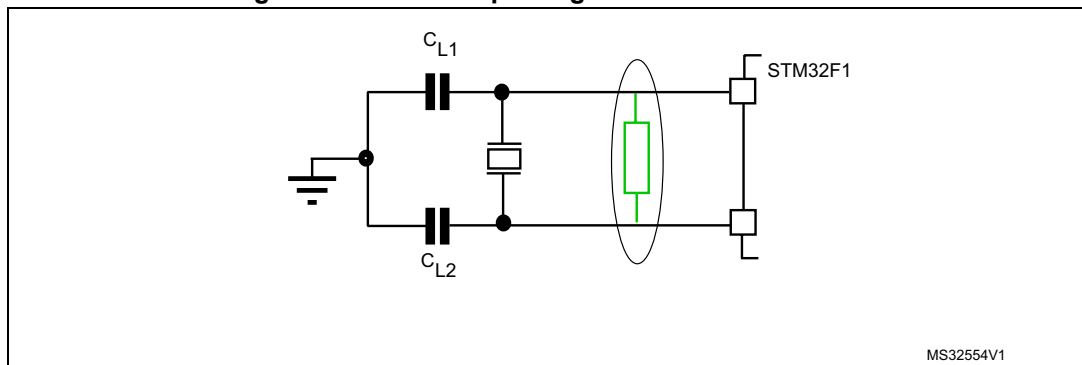
Figure 1. LSE start-up using an additional resistor

The LSE (Low Speed External) oscillator system has been designed to minimize the overall power consumption of the STM32F1 microcontroller. It is extremely important to take specific care in the design of the PCB to ensure this low power oscillator starts in harsh conditions. In some PCB designs without coating, an induced low leakage may prevent the LSE to start-up, regardless of the 32.768 KHz crystal used. This phenomenon is amplified in humid environments that create frost on the OSC32_IN/OSC32_OUT tracks. This unwanted behavior may happen only at the first back-up domain power-on of the device.

It is recommended to mount an additional parallel feedback resistor (from 16 M Ω to 22 M Ω) on board to help the oscillation start-up in all cases (see [Figure 1](#)). For more details on compatible crystals and hardware techniques on PCB, refer to AN2867 application note.
