STM32F105xx, STM32F107xx device errata

This document applies to the part numbers of STM32F105xx, STM32F107xx devices and the device variants as stated in this page.

It gives a summary and a description of the device errata, with respect to the device datasheet and reference manual RM0008. Deviation of the real device behavior from the intended device behavior is considered to be a device limitation. Deviation of the description in the reference manual or the datasheet from the intended device behavior is considered to be a documentation erratum. The term “*errata*” applies both to limitations and documentation errata.

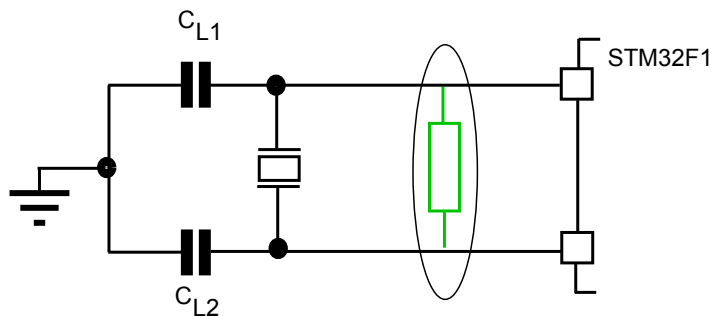
Figure 1. LSE startup using an additional resistor

The LSE (low-speed external) oscillator system has been designed to minimize the overall power consumption of the microcontroller. It is extremely important to take specific care in the design of the PCB to ensure this low power oscillator starts in harsh conditions. In some PCB designs without coating, an induced low leakage may prevent the LSE to startup, regardless of the 32.768 KHz crystal used. This phenomenon is amplified in humid environments that create frost on the OSC32_IN/OSC32_OUT tracks. This unwanted behavior may happen only at the first back-up domain power-on of the device.

It is recommended to mount an additional parallel feedback resistor (from 16 MΩ to 22 MΩ) on board to help the oscillation startup in all cases (see [Figure 1](#)). For more details on compatible crystals and hardware techniques on PCB, refer to application note *Oscillator design guide for STM8AF/AL/S, STM32 MCUs and MPUs* (AN2867).
