STM32F100x4, STM32F100x6, STM32F100x8 and STM32F100xB low and medium-density value line device errata

This document applies to the part numbers of STM32F100x4, STM32F100x6, STM32F100x8 and STM32F100xB low and medium-density value line devices and the device variants as stated in this page.

It gives a summary and a description of the device errata, with respect to the device datasheet and reference manual RM00041.

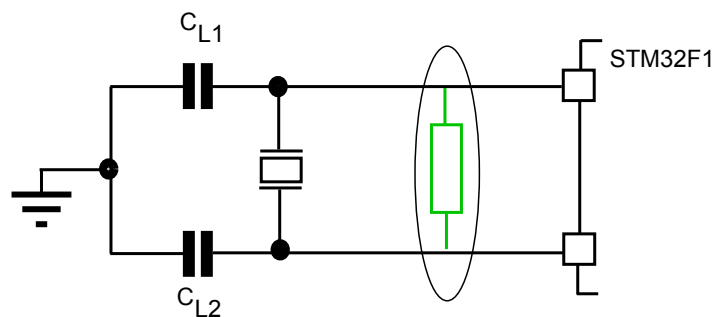
Figure 1. LSE startup using an additional resistor

The LSE (low-speed external) oscillator system has been designed to minimize the overall power consumption of the microcontroller. It is extremely important to take specific care in the design of the PCB to ensure this low power oscillator starts in harsh conditions. In some PCB designs without coating, an induced low leakage may prevent the LSE to startup, regardless of the 32.768 KHz crystal used. This phenomenon is amplified in humid environments that create frost on the OSC32_IN/OSC32_OUT tracks. This unwanted behavior may happen only at the first back-up domain power-on of the device.

It is recommended to mount an additional parallel feedback resistor (from 16 M Ω to 22 M Ω) on board to help the oscillation startup in all cases (see Figure 1). For more details on compatible crystals and hardware techniques on PCB, refer to application note *Oscillator design guide for STM8AF/AL/S, STM32 MCUs and MPUs* (AN2867).
