STM8S001J3, STM8S003xx, STM8S103xx and STM8S903xx device limitations

This errata sheet applies to the STMicroelectronics STM8S001J3, STM8S003xx, STM8S103xx and STM8S903xx devices.

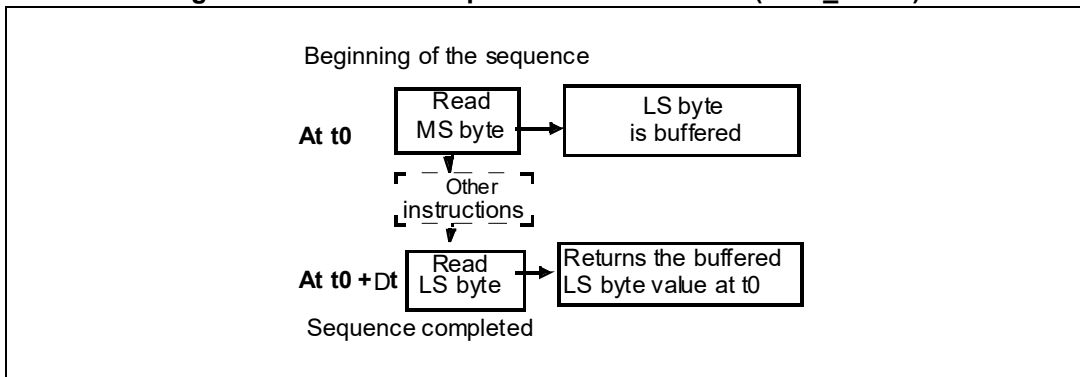
Figure 1. 16-bit read sequence for the counter (TIMx_CNTR)

An 8-bit buffer is implemented for reading the 16-bit counter registers. Software must read the MS byte first, after which the LS byte value is buffered automatically (see [Figure 1](#)). This buffered value remains unchanged until the 16-bit read sequence is completed.

When any multi-cycle instruction precedes the read of the LSB, the content of the buffer is lost and the second read returns the immediate content of the counter directly.

Do not use multi-cycle instructions before reading the LSB.
