STM32F101xF/G and STM32F103xF/G XL-density device errata

This document applies to the part numbers of STM32F101xF/G and STM32F103xF/G XL-density devices and the device variants as stated in this page.

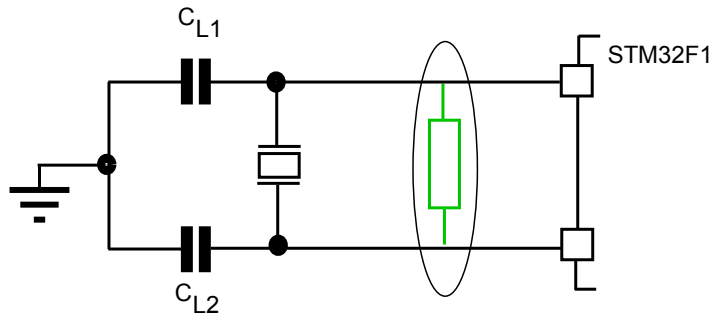
Figure 1. LSE startup using an additional resistor

The LSE (low-speed external) oscillator system has been designed to minimize the overall power consumption of the microcontroller. It is extremely important to take specific care in the design of the PCB to ensure this low power oscillator starts in harsh conditions. In some PCB designs without coating, an induced low leakage may prevent the LSE to startup, regardless of the 32.768 KHz crystal used. This phenomenon is amplified in humid environments that create frost on the OSC32_IN/OSC32_OUT tracks. This unwanted behavior may happen only at the first back-up domain power-on of the device.

It is recommended to mount an additional parallel feedback resistor (from 16 MΩ to 22 MΩ) on board to help the oscillation startup in all cases (see [Figure 1](#)). For more details on compatible crystals and hardware techniques on PCB, refer to application note *Oscillator design guide for STM8AF/AL/S, STM32 MCUs and MPUs* (AN2867).
