## Silicon identification

This errata sheet applies to the revision A or 1 of the STMicroelectronics STM32F101xF/G access line and STM32F103xF/G performance line XL-density products. These families feature an Arm® 32-bit Cortex®-M3 core, for which an errata notice is also available (see [Section 1](#) for details).

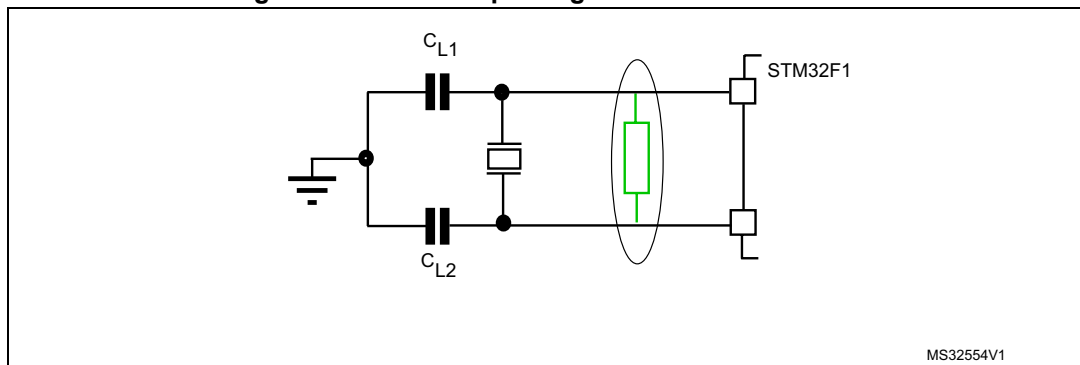
Figure 1. LSE start-up using an additional resistor

The LSE (Low Speed External) oscillator system has been designed to minimize the overall power consumption of the STM32F1 microcontroller. It is extremely important to take specific care in the design of the PCB to ensure this low power oscillator starts in harsh conditions. In some PCB designs without coating, an induced low leakage may prevent the LSE to start-up, regardless of the 32.768 KHz crystal used. This phenomenon is amplified in humid environments that create frost on the OSC32\_IN/OSC32\_OUT tracks. This unwanted behavior may happen only at the first back-up domain power-on of the device.

It is recommended to mount an additional parallel feedback resistor (from 16 M $\Omega$  to 22 M $\Omega$ ) on board to help the oscillation start-up in all cases (see [Figure 1](#)). For more details on compatible crystals and hardware techniques on PCB, refer to AN2867 "Oscillator design guide for STM8AF/AL/S, STM32 MCUs and MPUs" available on [www.st.com](http://www.st.com).
