STM32L151x6/8/B and STM32L152x6/8/B device errata

Applicability

This document applies to the part numbers of STM32L151x6/8/B and STM32L152x6/8/B devices and the device variants as stated in this page.

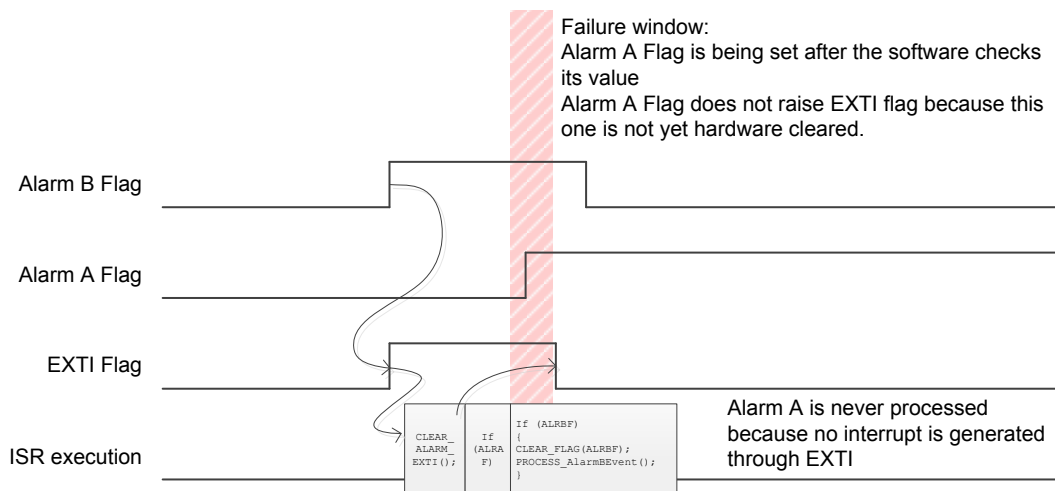
Figure 1. Masked RTC interrupt

The following code example and figure illustrate the failure mechanism: The Alarm A event is lost (fails to generate interrupt) as it occurs in the failure window, that is, after checking the Alarm A event flag but before the effective clear of the EXTI interrupt flag by hardware. The effective clear of the EXTI interrupt flag is delayed with respect to the software instruction to clear it.

In the interrupt service routine, apply three consecutive event flag checks - source one, source two, and source one again, as in the following code example:
