STM32F030x4/x6/x8/xC device errata

Applicability

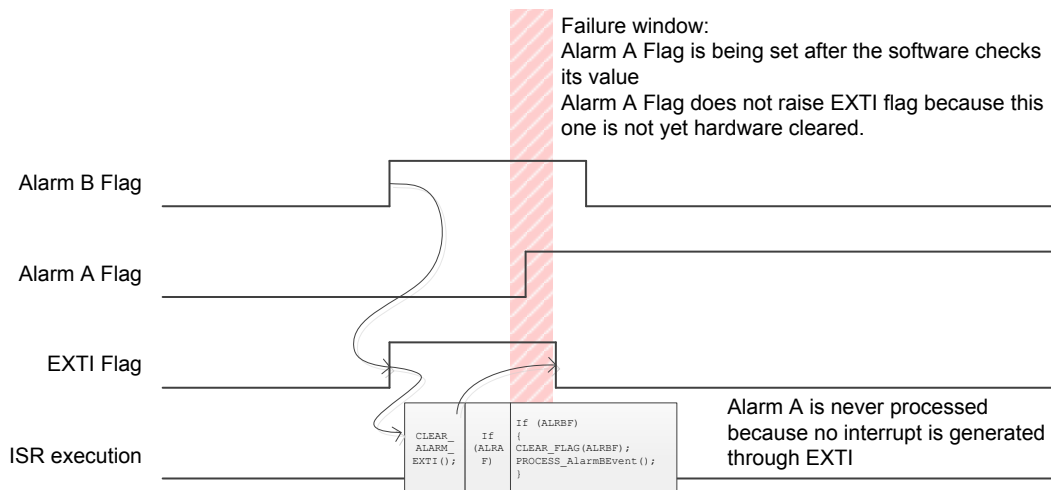
Figure 1. Masked RTC interrupt

The following code example and figure illustrate the failure mechanism: The Alarm A event is lost (fails to generate interrupt) as it occurs in the failure window, that is, after checking the Alarm A event flag but before the effective clear of the EXTI interrupt flag by hardware. The effective clear of the EXTI interrupt flag is delayed with respect to the software instruction to clear it.

Workaround

In the interrupt service routine, apply three consecutive event flag checks - source one, source two, and source one again, as in the following code example:
