STM32F302x6/x8 device errata

This document applies to the part numbers of STM32F302x6/x8 devices and the device variants as stated in this page.

It gives a summary and a description of the device errata, with respect to the device datasheet and reference manual RM0366.

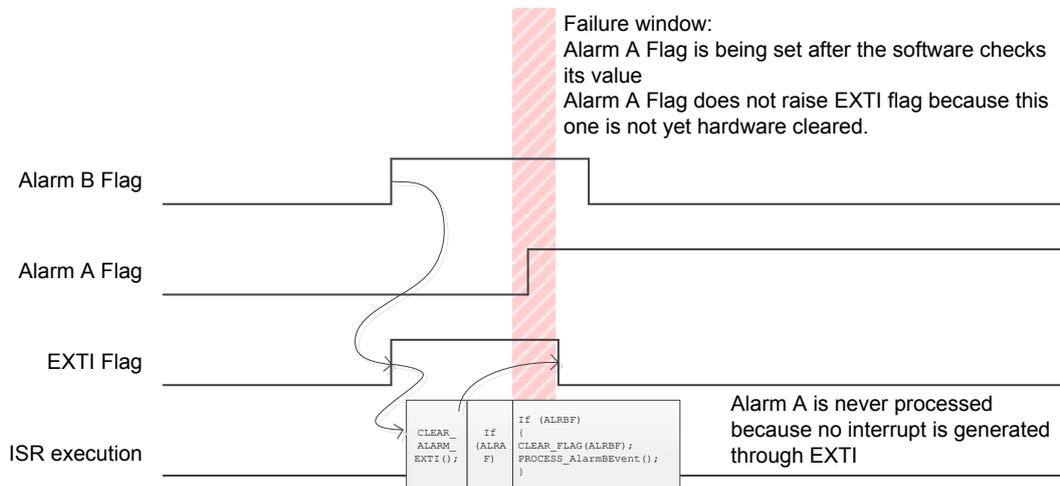
Figure 1. Masked RTC interrupt

The following code example and figure illustrate the failure mechanism: The Alarm A event is lost (fails to generate interrupt) as it occurs in the failure window, that is, after checking the Alarm A event flag but before the effective clear of the EXTI interrupt flag by hardware. The effective clear of the EXTI interrupt flag is delayed with respect to the software instruction to clear it.

Workaround

In the interrupt service routine, apply three consecutive event flag checks - source one, source two, and source one again, as in the following code example:
