STM32L05xxx/L06xxx device errata

Applicability

This document applies to the part numbers of STM32L05xxx/L06xxx devices and the device variants as stated in this page. It gives a summary and a description of the device errata, with respect to the device datasheet and reference manual RM0367/RM0376/RM0377.

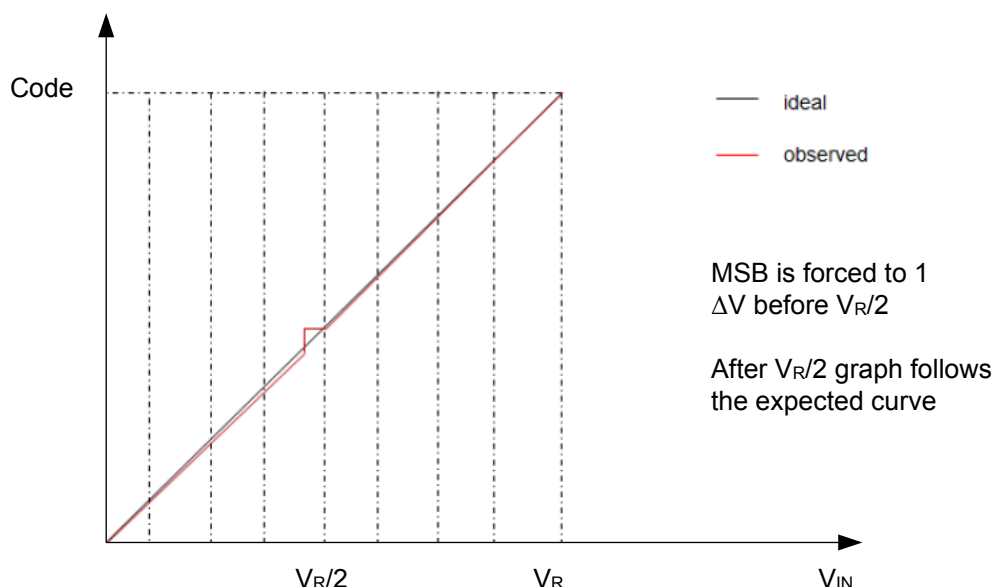
Figure 1. Data transfer curve

When V_{REF+} is lower than V_{DDA} , and only in this case, the data MSB is forced to 1 just before V_{IN} reaches $V_{REF+}/2$. As a result, the data transfer curve shows a discrepancy around $V_{REF+}/2$ (see [Figure 1](#)).

1. The transfer curve behaves as expected when V_{IN} is strictly lower or higher than $V_{REF+}/2$.

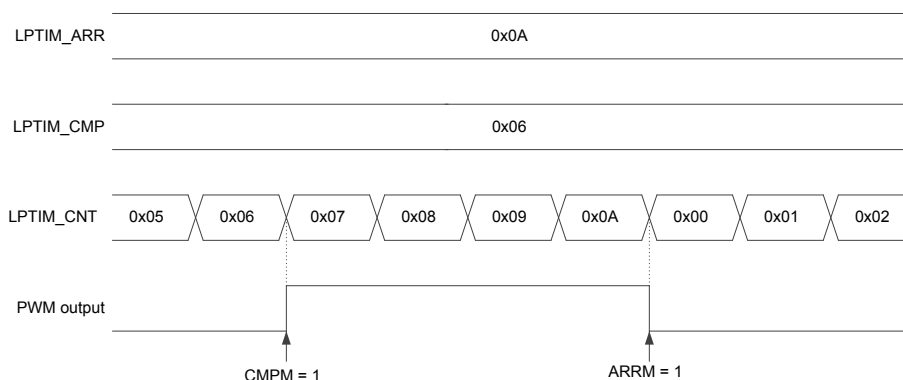
Figure 2. Example of PWM output mode

The following waveform gives the example of PWM output mode and the effect of the delay:

Set the compare value to the desired value minus 1. For instance in order to generate a compare match when LPTM_CNT = 0x08, set the compare value to 0x07.

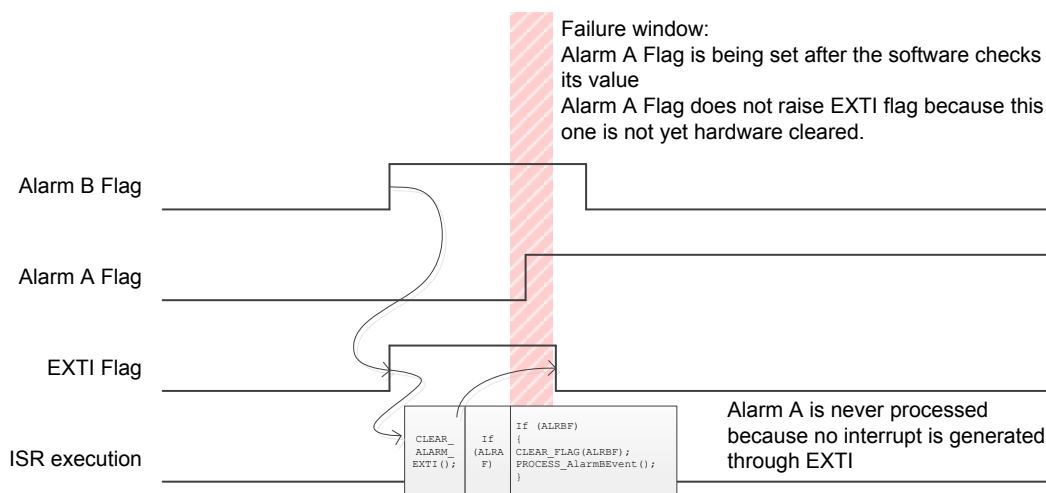
Figure 3. Masked RTC interrupt

The following code example and figure illustrate the failure mechanism: The Alarm A event is lost (fails to generate interrupt) as it occurs in the failure window, that is, after checking the Alarm A event flag but before the effective clear of the EXTI interrupt flag by hardware. The effective clear of the EXTI interrupt flag is delayed with respect to the software instruction to clear it.
