STM32L031xx/L041xx device errata

Applicability

This document applies to the part numbers of STM32L031xx/L041xx devices and the device variants as stated in this page. It gives a summary and a description of the device errata, with respect to the device datasheet and reference manual RM0377. Deviation of the real device behavior from the intended device behavior is considered to be a device limitation. Deviation of the description in the reference manual or the datasheet from the intended device behavior is considered to be a documentation erratum. The term “*errata*” applies both to limitations and documentation errata.

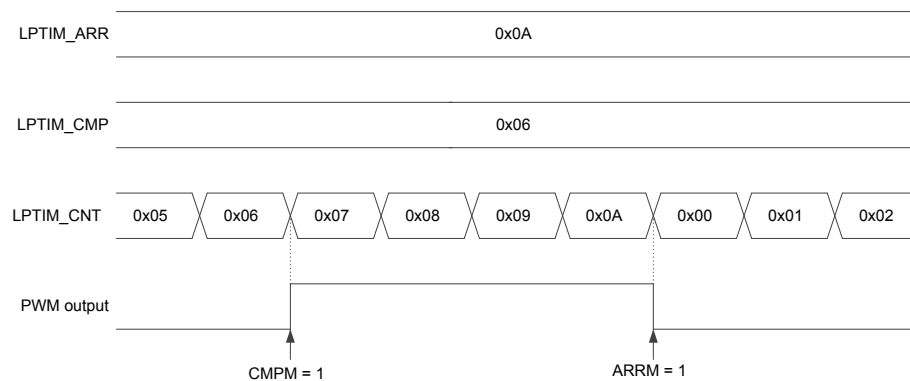
Consequently, it is not possible to generate PWM with a duty cycle of 0% or 100%.

The following waveform gives the example of PWM output mode and the effect of the delay:

Workaround

Set the compare value to the desired value minus 1. For instance in order to generate a compare match when LPTM_CNT = 0x08, set the compare value to 0x07.
