STM32L011xx/L021xx device errata

Applicability

This document applies to the part numbers of STM32L011xx/L021xx devices and the device variants as stated in this page. It gives a summary and a description of the device errata, with respect to the device datasheet and reference manual RM0377. Deviation of the real device behavior from the intended device behavior is considered to be a device limitation. Deviation of the description in the reference manual or the datasheet from the intended device behavior is considered to be a documentation erratum. The term “errata” applies both to limitations and documentation errata.

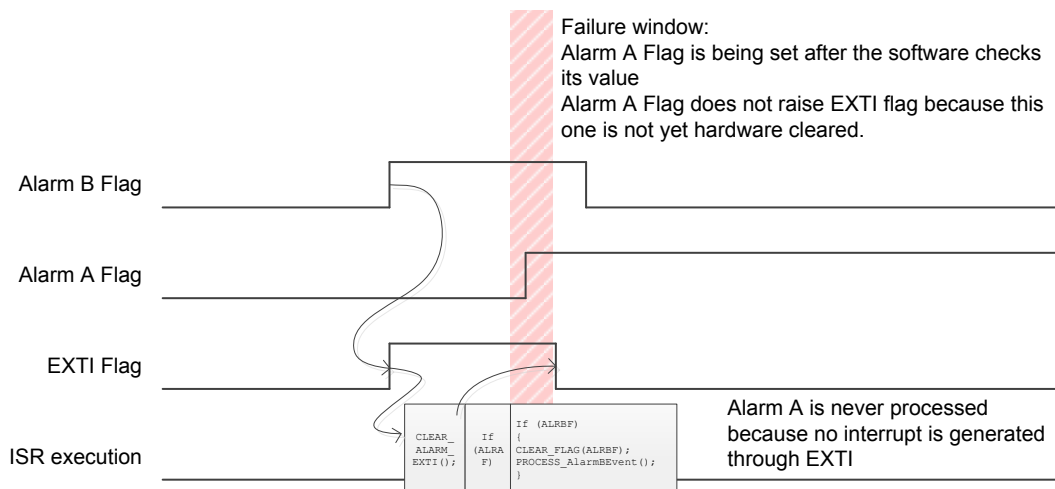
Figure 1. Masked RTC interrupt

The following code example and figure illustrate the failure mechanism: The Alarm A event is lost (fails to generate interrupt) as it occurs in the failure window, that is, after checking the Alarm A event flag but before the effective clear of the EXTI interrupt flag by hardware. The effective clear of the EXTI interrupt flag is delayed with respect to the software instruction to clear it.

In the interrupt service routine, apply three consecutive event flag checks - source one, source two, and source one again, as in the following code example:
