STM32L451xx device errata

This document applies to the part numbers of STM32L451xx devices and the device variants as stated in this page.

It gives a summary and a description of the device errata, with respect to the device datasheet and reference manual RM0394.

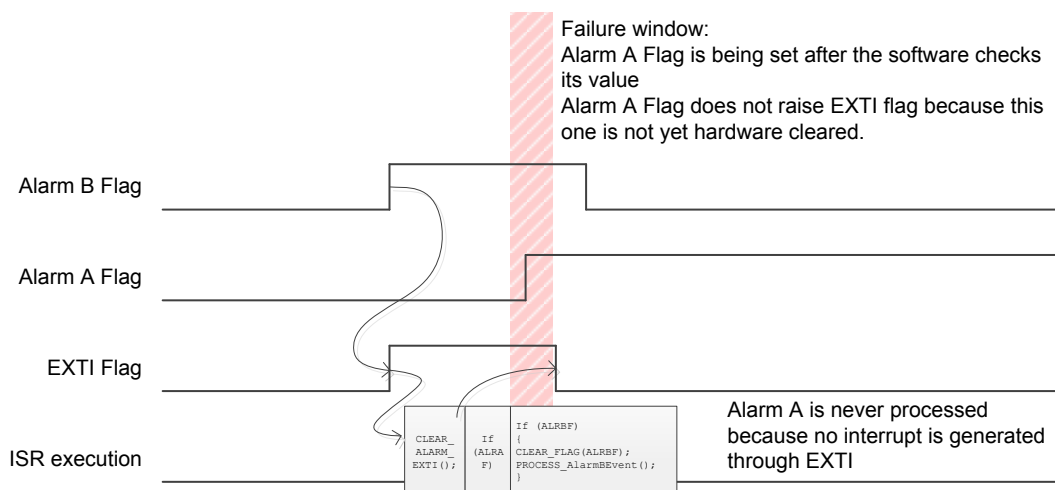
Figure 1. Masked RTC interrupt

The following code example and figure illustrate the failure mechanism: The Alarm A event is lost (fails to generate interrupt) as it occurs in the failure window, that is, after checking the Alarm A event flag but before the effective clear of the EXTI interrupt flag by hardware. The effective clear of the EXTI interrupt flag is delayed with respect to the software instruction to clear it.

Workaround

In the interrupt service routine, apply three consecutive event flag checks - source one, source two, and source one again, as in the following code example:
