STM32H742xI/G, STM32H743xI/G STM32H750xB, STM32H753xI

Errata sheet

STM32H742xI/G, STM32H743xI/G, STM32H750xB, STM32H753xI device errata

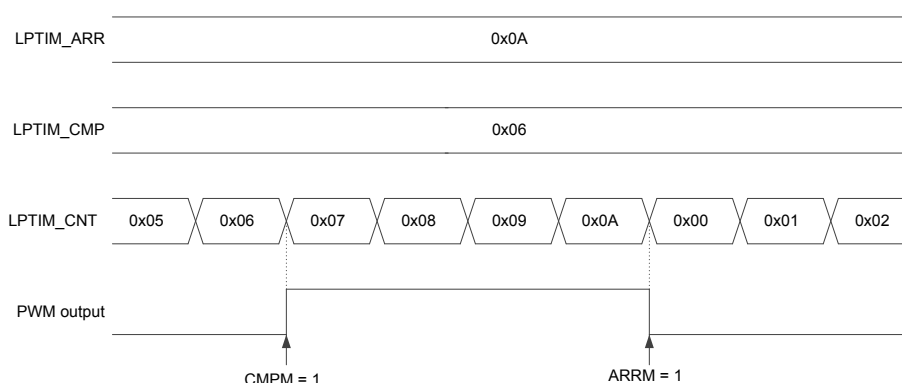
Figure 1. Example of PWM output mode

The following waveform gives the example of PWM output mode and the effect of the delay:

Set the compare value to the desired value minus 1. For instance in order to generate a compare match when LPTIM_CNT = 0x08, set the compare value to 0x07.

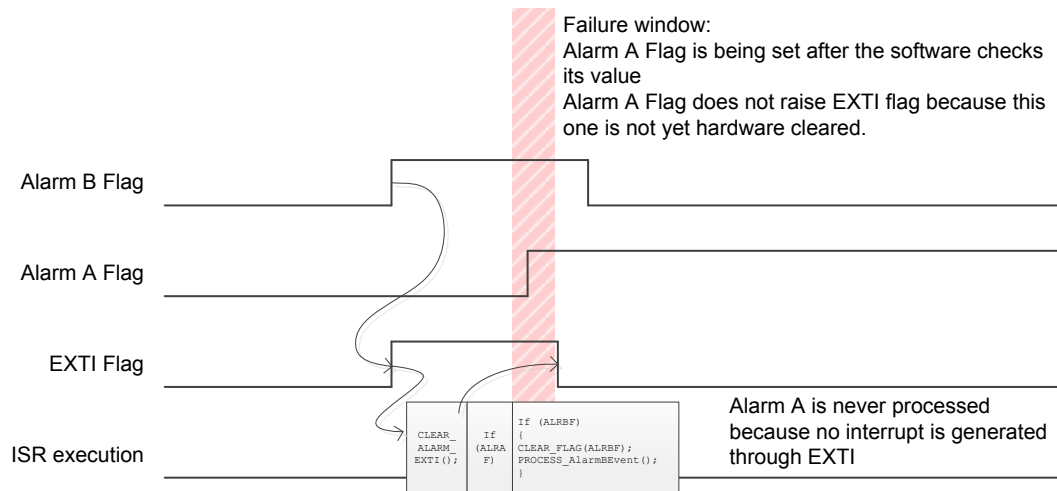
Figure 2. Masked RTC interrupt

The following code example and figure illustrate the failure mechanism: The Alarm A event is lost (fails to generate interrupt) as it occurs in the failure window, that is, after checking the Alarm A event flag but before the effective clear of the EXTI interrupt flag by hardware. The effective clear of the EXTI interrupt flag is delayed with respect to the software instruction to clear it.

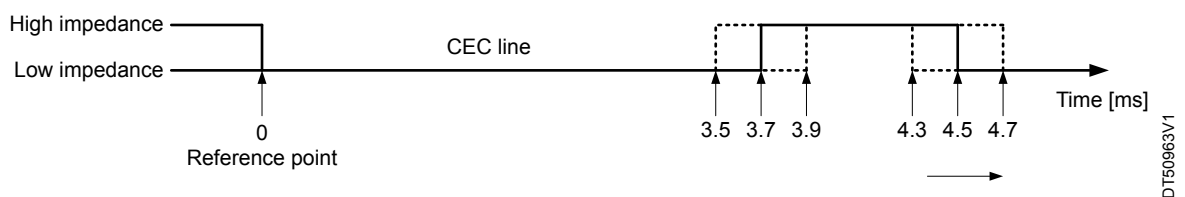
Figure 3. CEC start bit format with tolerances

If one of these conditions is not met, the transmission is aborted and never automatically retried. No error flag is set and the TXSOM (Tx Start Of Message) bit is not cleared.

The only way to detect this error is for the application software to start a timeout when setting the TXSOM bit, restart it upon ARBLST or any RX event (as the transmission can be delayed by interleaved reception), and stop it upon TXBR (proof that the start bit was transmitted successfully) or TXEND event, or upon any TX error (which clears TXSOM). If the timeout expires (because none of those events occurred), the application software must restart the CEC peripheral and retransmit the message.
