STM32L4Rxxx and STM32L4Sxxx device errata

This document applies to the part numbers of STM32L4Rxxx and STM32L4Sxxx devices and the device variants as stated in this page.

It gives a summary and a description of the device errata, with respect to the device datasheet and reference manual RM0432.

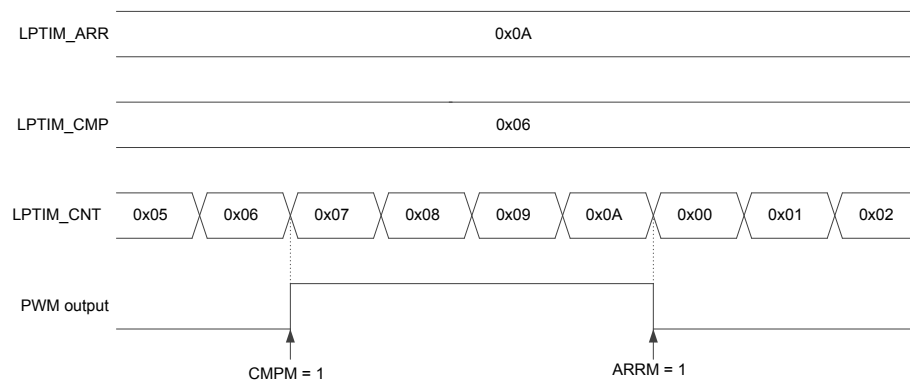
Consequently, it is not possible to generate PWM with a duty cycle of 0% or 100%.

The following waveform gives the example of PWM output mode and the effect of the delay:

Set the compare value to the desired value minus 1. For instance in order to generate a compare match when LPTIM_CNT = 0x08, set the compare value to 0x07.

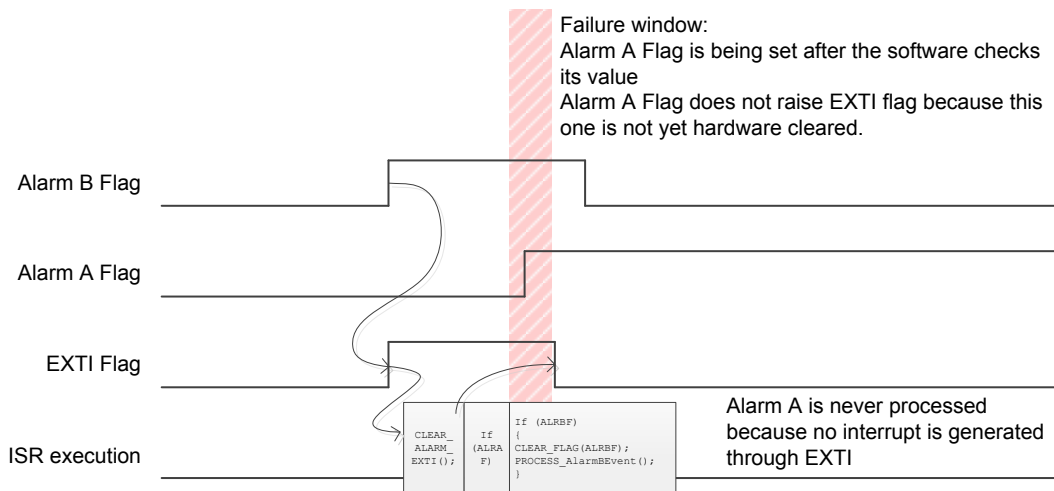
Figure 1. Masked RTC interrupt

The following code example and figure illustrate the failure mechanism: The Alarm A event is lost (fails to generate interrupt) as it occurs in the failure window, that is, after checking the Alarm A event flag but before the effective clear of the EXTI interrupt flag by hardware. The effective clear of the EXTI interrupt flag is delayed with respect to the software instruction to clear it.

In the interrupt service routine, apply three consecutive event flag checks - source one, source two, and source one again, as in the following code example:
