STM32WB55xx/STM32WB35Cx device errata

This document applies to the part numbers of STM32WB55xx/STM32WB35Cx devices and the device variants as stated in this page.

It gives a summary and a description of the device errata, with respect to the device datasheet and reference manual RM0434.

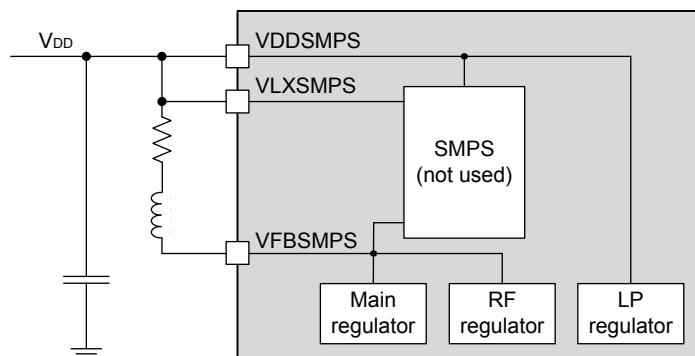
Figure 1. Workaround

The inductance features are 1.8 nH +/- 0.1 nH, a self-resonance frequency of 6 Ghz +/- 15 % and rated current of 1000 mA. Refer to [Minimal BOM for STM32WB Series microcontrollers \(AN5290\)](#) for more details.

The recommended values are:

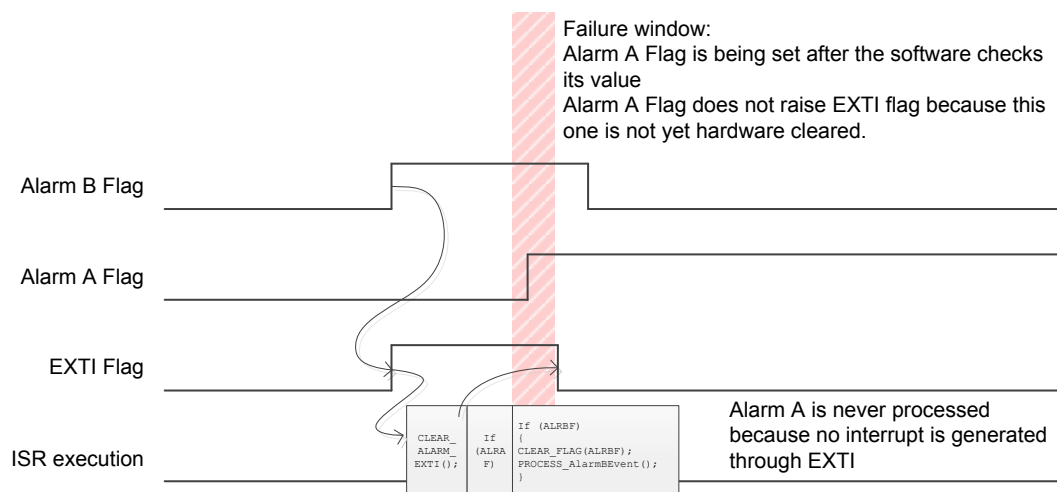
Figure 2. Masked RTC interrupt

The following code example and figure illustrate the failure mechanism: The Alarm A event is lost (fails to generate interrupt) as it occurs in the failure window, that is, after checking the Alarm A event flag but before the effective clear of the EXTI interrupt flag by hardware. The effective clear of the EXTI interrupt flag is delayed with respect to the software instruction to clear it.

In the interrupt service routine, apply three consecutive event flag checks - source one, source two, and source one again, as in the following code example:
