## STM32G471xx/473xx/474xx/483xx/484xx device errata

### Applicability

This document applies to the part numbers of STM32G471xx/473xx/474xx/483xx/484xx devices and the device variants as stated in this page.

It gives a summary and a description of the device errata, with respect to the device datasheet and reference manual RM0440.

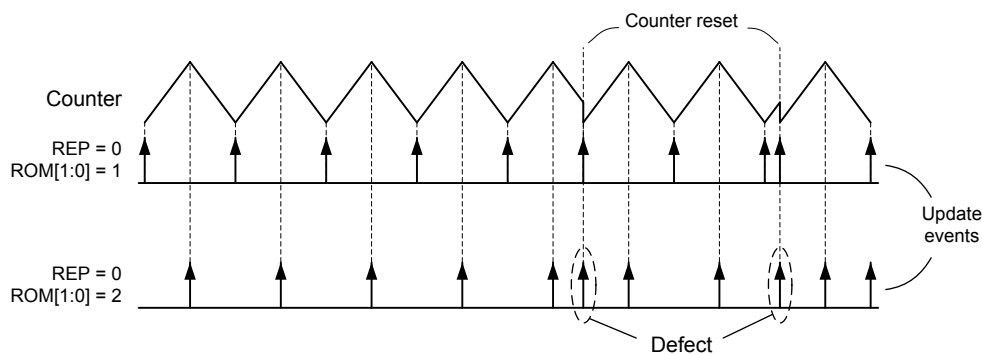
**2.11 HRTIM**
**2.11.1 Spurious register update event in up-down counting mode**
**Description**

In up-down counting mode, the value 2 in the roll-over mode bitfield ROM[1:0] sets the corresponding roll-over event to occur when the counter rolls over the crest, which then induces timer register update, based on other settings. However, with ROM[1:0] at 2, the register update is also unduly triggered upon the counter reset, as illustrated:

The defect impacts the timer x operation with the following settings:

- TxREPU = 1, for the update when the timer x repetition counter reaches zero (in this case, the spurious roll-over event at the counter reset propagates to register update event while not decrementing the repetition counter)
- TxRSTU = 1, for the update upon timer x reset
- RSYNCU = 1, for the update re-synchronized with the counter roll-over event

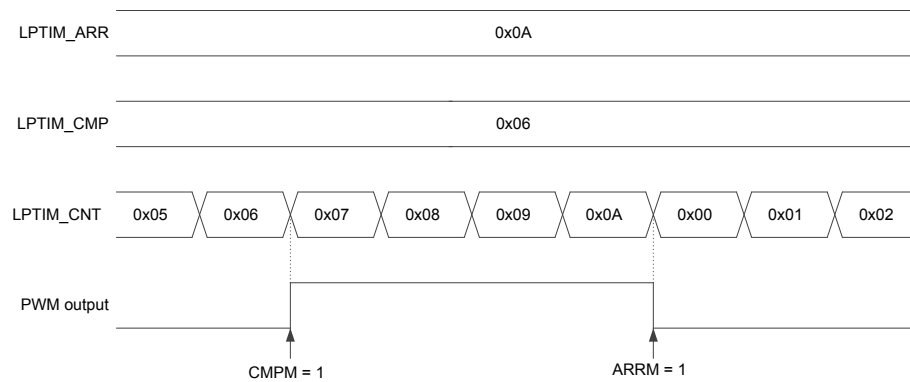
**Figure 1. Example of PWM output mode**

The following waveform gives the example of PWM output mode and the effect of the delay:

Set the compare value to the desired value minus 1. For instance in order to generate a compare match when LPTM\_CNT = 0x08, set the compare value to 0x07.
