## STM32G431xx/441xx device errata

This document applies to the part numbers of STM32G431xx/441xx devices and the device variants as stated in this page. It gives a summary and a description of the device errata, with respect to the device datasheet and reference manual RM0440. Deviation of the real device behavior from the intended device behavior is considered to be a device limitation. Deviation of the description in the reference manual or the datasheet from the intended device behavior is considered to be a documentation erratum. The term “*errata*” applies both to limitations and documentation errata.

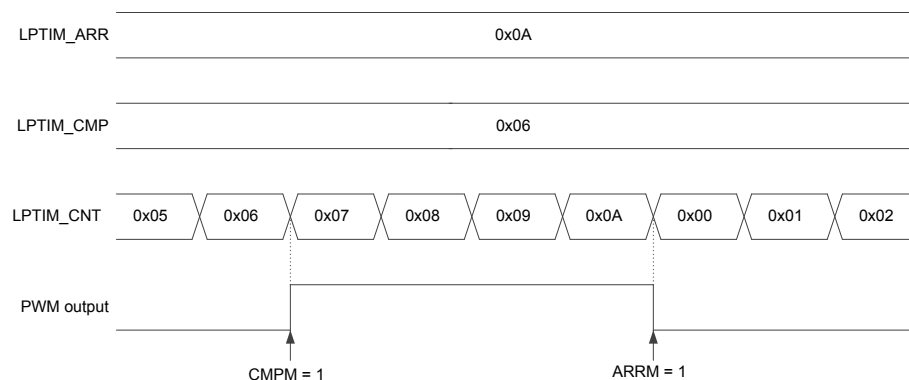
Consequently, it is not possible to generate PWM with a duty cycle of 0% or 100%.

The following waveform gives the example of PWM output mode and the effect of the delay:

### Workaround

Set the compare value to the desired value minus 1. For instance in order to generate a compare match when LPTIM\_CNT = 0x08, set the compare value to 0x07.
