The BlueNRG-1 device limitations

This errata sheet applies to the following STMicroelectronics BlueNRG-1 devices:

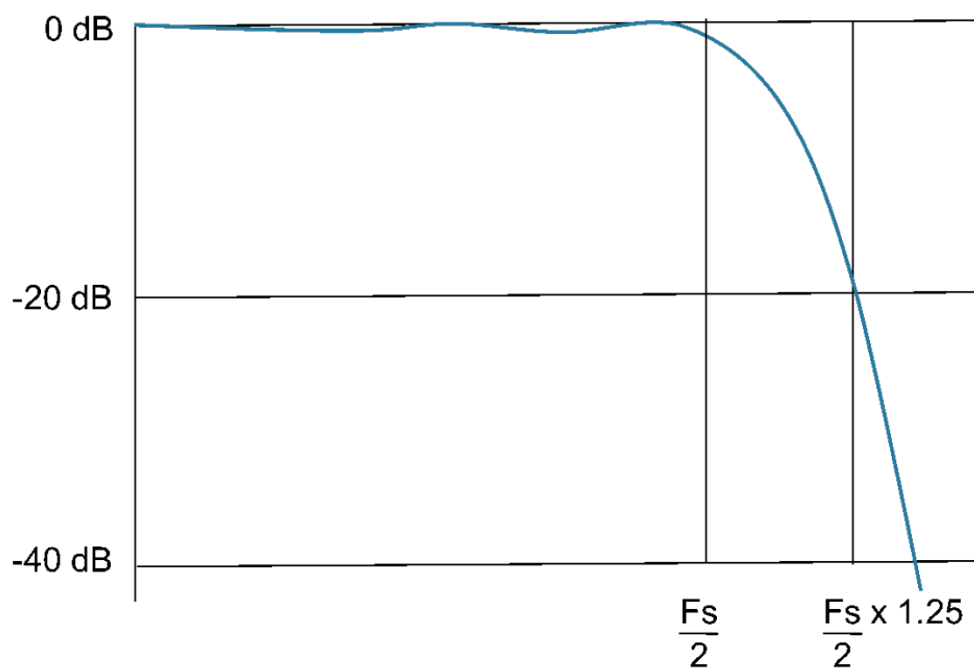
Figure 1. Interpolation filter frequency response

Description: the bandwidth of the anti-aliasing filter is slightly broader with respect to the signal bandwidth, potentially thus generating unwanted aliased signal after the decimation filter.

Impact: When a pure sine wave, generated in the $[F_s/2; 1.25 \cdot F_s/2]$ range, is being sampled, user can notice an attenuated aliased sine wave in the $[0.75 \cdot F_s/2; F_s/2]$ range.

In case of waveform acquisition, especially when audio speech and music is caught, no further degradation has been identified.

Workaround: by choosing an appropriate oversampling factor (OSR), so that maximum frequency of the sampled signal is lower than $F_s/2$, aliasing may be avoided.
