STM32WB50CG/30CE device errata

This document applies to STM32WB50CG/30CE devices and the device variants as stated in this page.

It gives a summary and a description of the device errata, with respect to the device datasheet and reference manual RM0471.

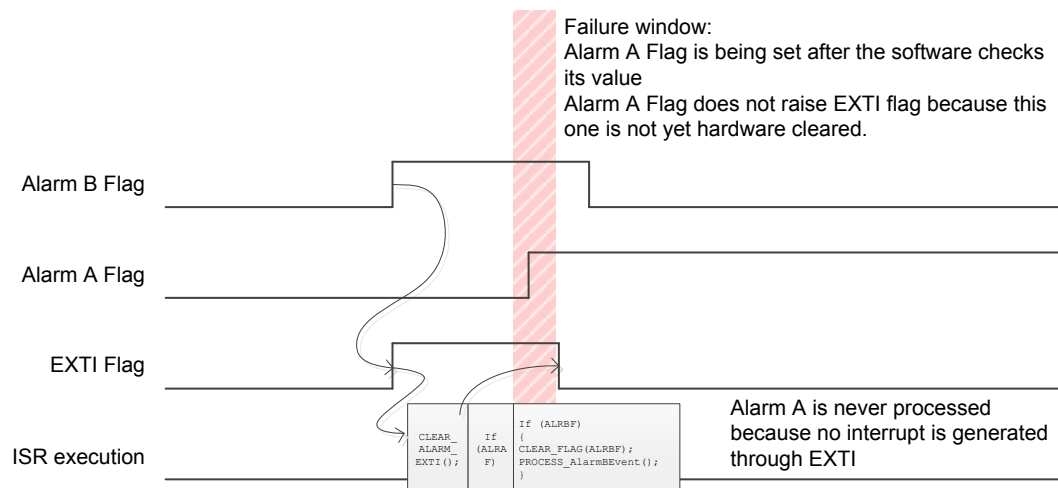
Figure 1. Masked RTC interrupt

The following code example and figure illustrate the failure mechanism: The Alarm A event is lost (fails to generate interrupt) as it occurs in the failure window, that is, after checking the Alarm A event flag but before the effective clear of the EXTI interrupt flag by hardware. The effective clear of the EXTI interrupt flag is delayed with respect to the software instruction to clear it.

Workaround

In the interrupt service routine, apply three consecutive event flag checks - source one, source two, and source one again, as in the following code example:
